**Annual EPBC Approval 2012/6548 Ornamental Snake Audit  
Train Load Out Facility – Moura  
Final Report**

**Baralaba Coal Company Pty Ltd**

**December 2022**

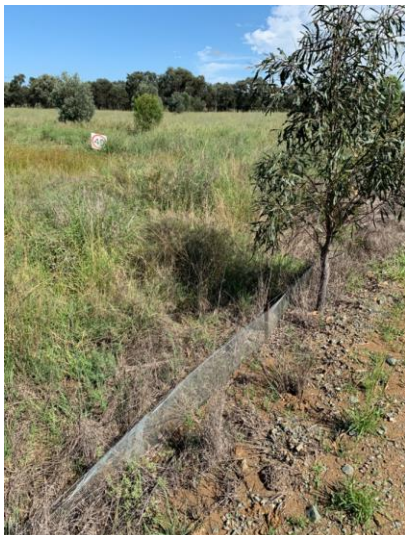
*Figure 1: Snake Exclusion Fencing*

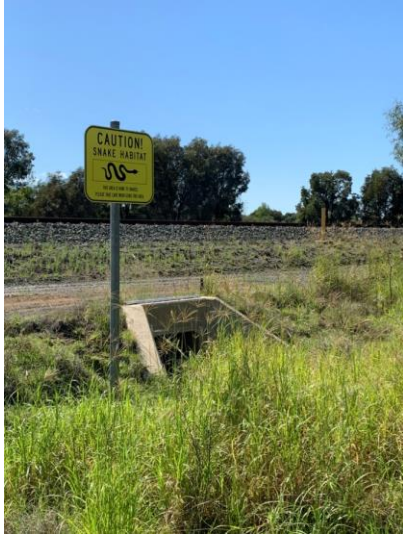
*Figure 2: Snake passage*

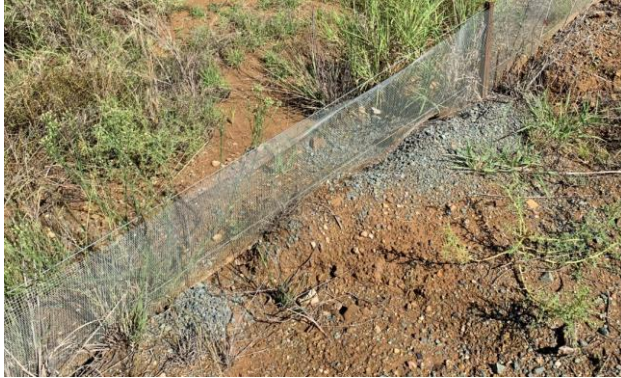
Sections of the exclusion fencing requires maintenance. Some sections are lying flat or overgrown by grass and in rare instances, the soil has eroded underneath the fence (Figures 3 & 4).

*Figure 3: Soil eroded underneath exclusion fencing*

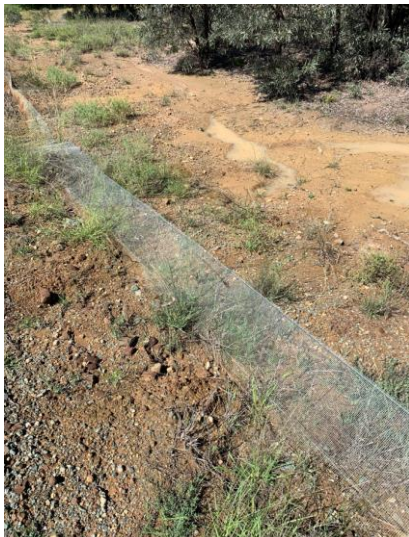
*Figure 4: Damaged exclusion fencing*

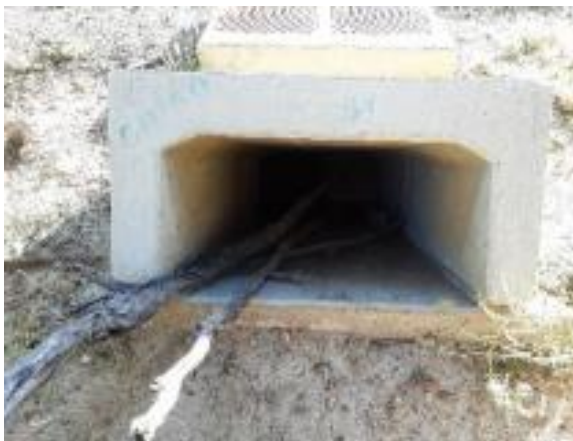
The fauna passages have been maintained.

*Figure 5: Fauna passage*

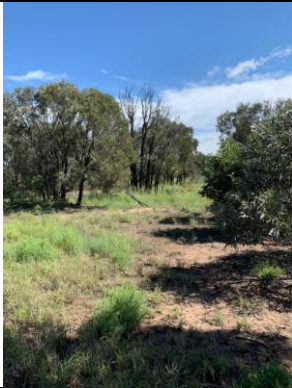
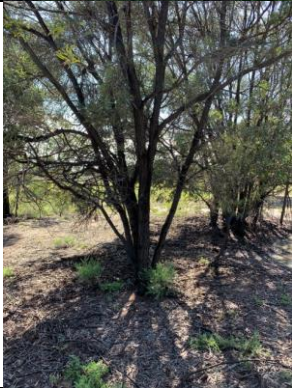
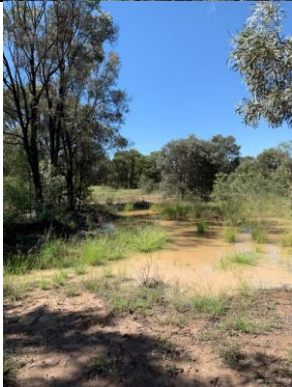
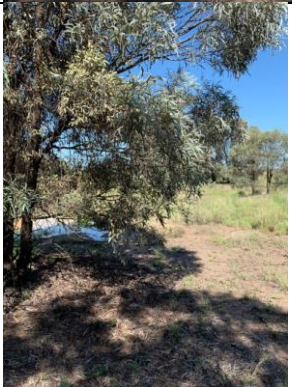
<b>Date &amp; Time</b>	13/12/2022 0857	
<b>Site</b>	O2	
<b>Observer</b>	B.Topp	
<b>Location</b>	-24.55064, 150.01213	
<b>North</b>

<b>Weeds</b>	None observed	
<b>Comments</b>	Wet. Some bare areas of ground.

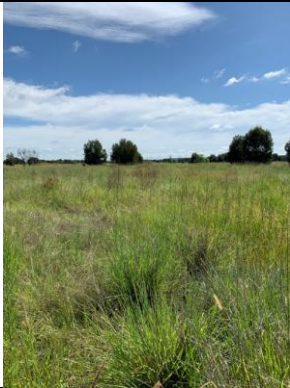
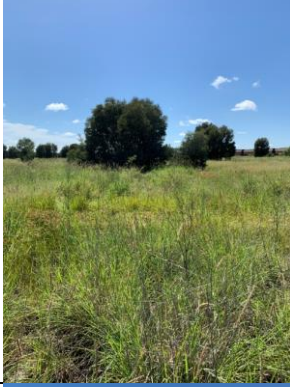
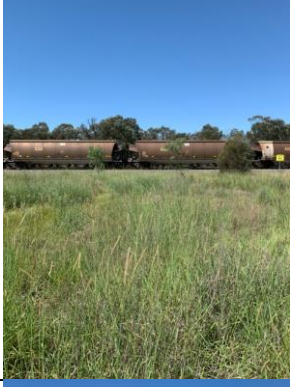
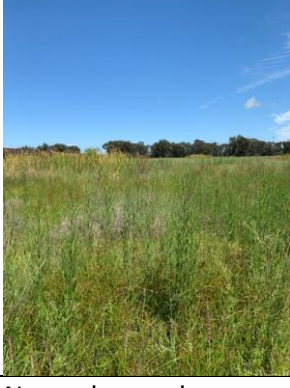
<b>Date &amp; Time</b>	13/12/2022 0914	
<b>Site</b>	O3	
<b>Observer</b>	B.Topp	
<b>Location</b>	-24.55243, 150.00702	
<b>North</b>

<b>Weeds</b>	None observed	
<b>Comments</b>	Open landscape. Grass cover and growth exceptional

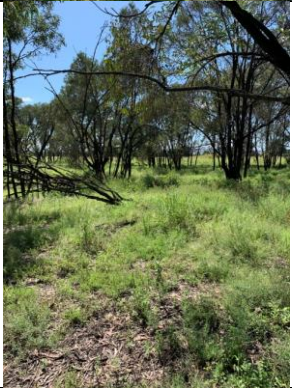
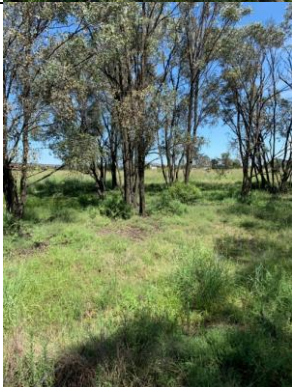
<b>Date &amp; Time</b>	13/12/2022 0924
<b>Site</b>	O4
<b>Observer</b>	B.Topp
<b>Location</b>	-24.55114, 150.00603
<b>North</b>	 
<b>East</b>

<b>Weeds</b>	None observed
<b>Comments</b>	Dense trees but grass cover still good underneath.

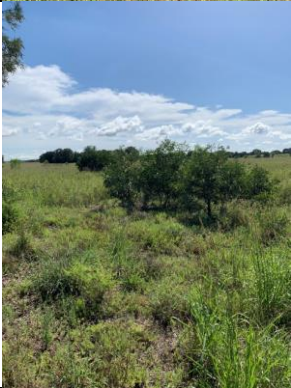
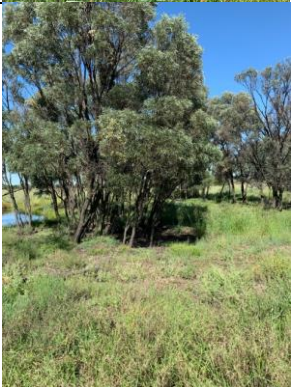
<b>Date &amp; Time</b>	13/12/2022 0838	
<b>Site</b>	O5	
<b>Observer</b>	B.Topp	
<b>Location</b>	-24.54883, 150.00883	
<b>North</b>	 	
<b>East</b>

<b>Weeds</b>	None observed	
<b>Comments</b>	Water pooling in the gilgai following overnight rainfall. The trees are in good condition as is the grass underneath.
