Annual EPBC Approval 2012/6548 Ornamental Snake Audit Train Load Out Facility – Moura Final Report

Baralaba Coal Company Pty Ltd

December 2023

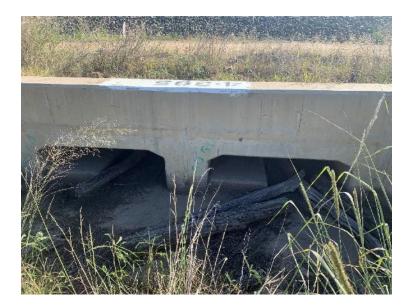
Figure 2: Snake signage

The exclusion fencing is in very good condition after the replacement earlier this year. The grass and weed growth around the fencing needs to be controlled in places (Figure 5). The signage and passages are in good condition (Figures 2-4).
