Baralaba South Project EIS

Aquatic Ecology Assessment Report

Prepared for: Baralaba South Pty Ltd

Prepared by: Ecological Service Professionals Pty Ltd

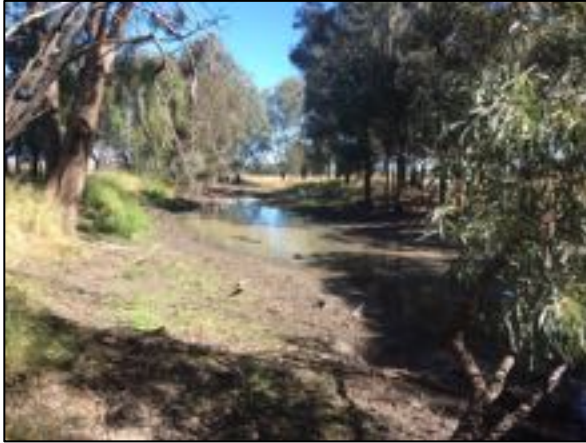
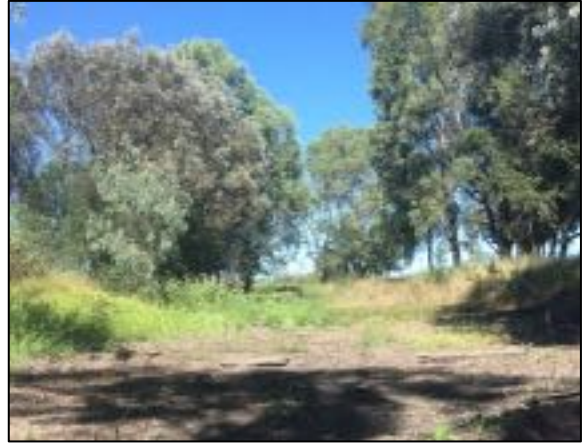
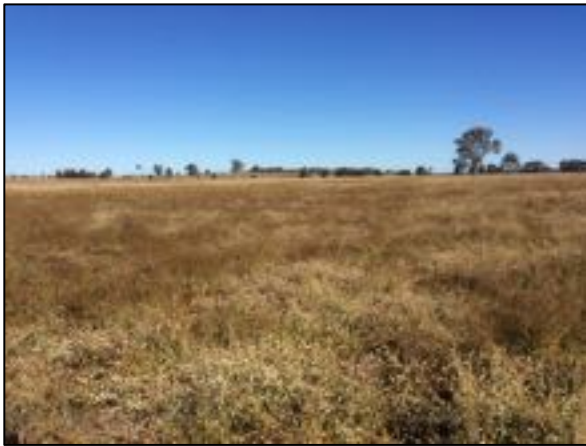
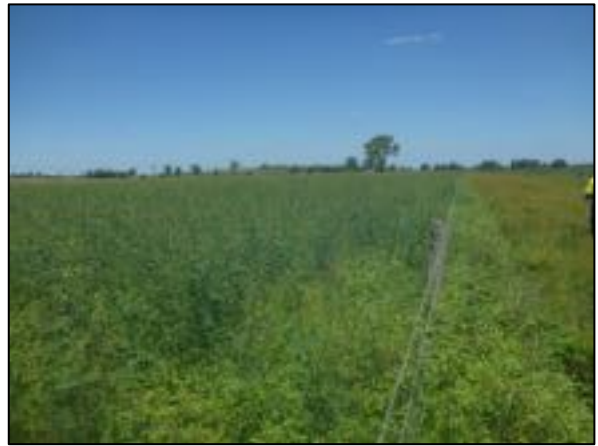
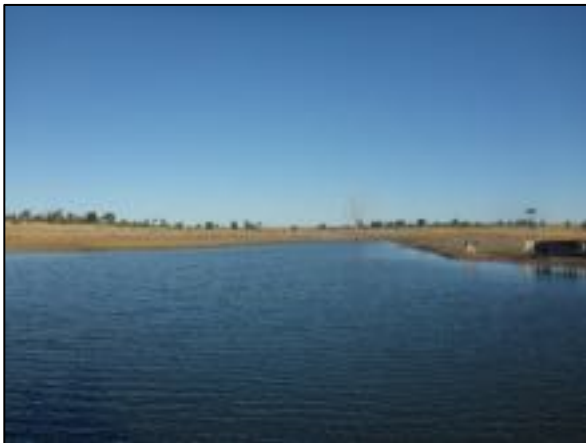
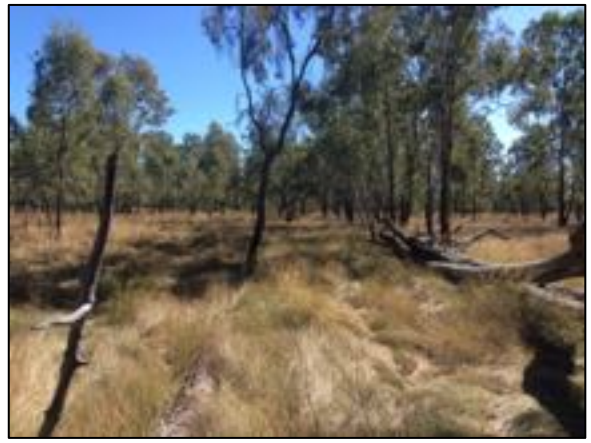
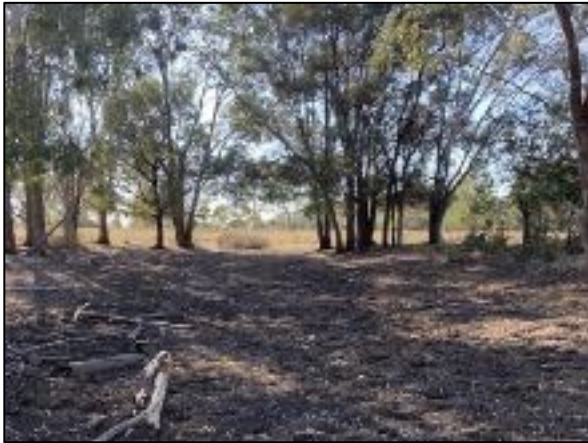
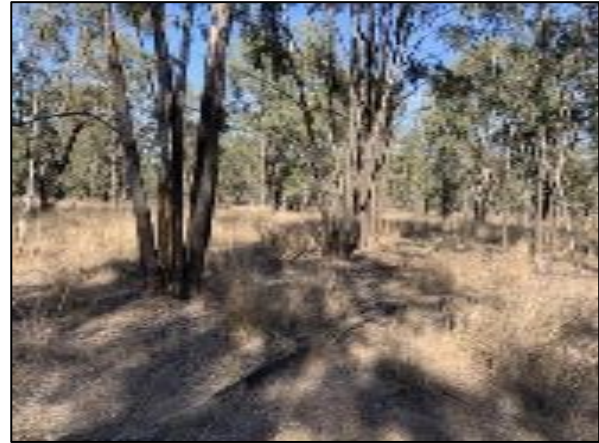
Figure 4.3 Photographs taken at sites on the minor waterways and wetlands within the Project area, including (a) upstream at site UW1T in June 2017; (b) upstream at site UW1T in March 2018; (c) site UW2 in June 2017; (d) site UW2 in March 2018; (e) facing upstream and showing bare riparian zone and cattle access at site LW11; (f) dry ephemeral HES wetland at site PW1 in June 2017; (g) upstream at site UW1T in August 2023; (h) north orientation at site PW1 in August 2023.

Aquatic habitat condition at sites within the Project area was poor to fair (Figure 4.5). The minor waterways within the Project area were generally considered to be in poor condition. They were characterised as ephemeral drainage lines or overland flow paths (i.e. no defined bed or banks) that had minimal in-stream habitat features (or were dry and largely disconnected) and were highly disturbed by activities associated with the adjacent land-use (e.g. riparian zone clearing and access by cattle) (Figure 4.3).

The wetland provides suitable potential habitat for aquatic fauna and would likely host a variety of aquatic flora for a short period of time when wetted. The proximity of the wetland to the Dawson River Anabranh provides the possibility for aquatic fauna to find refuge in the wetland after periods of high flow and flood events. However connectivity to other waterways would be rare and the wetland would not provide long-lasting habitat (Figure 4.3e,f). The

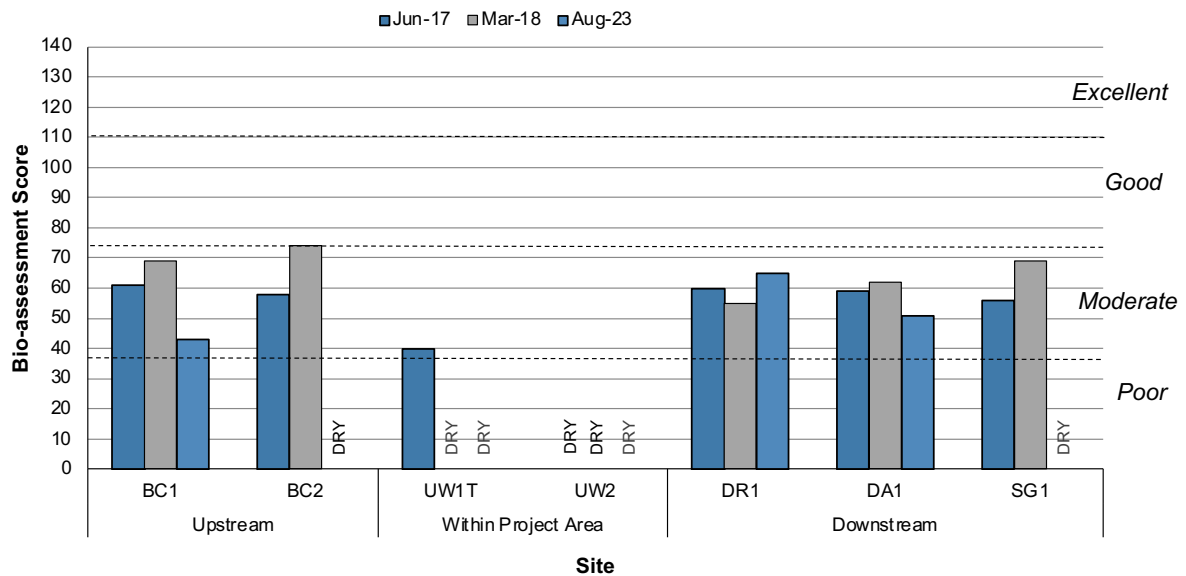
Figure 4.5 Bio-assessment scores for each waterway site that held water in June 2017, March 2018, and August 2023.

Water levels of Banana Creek, Shirley's Gully and the Dawson River Anabranche were lower during the August 2023 site inspection than during the comprehensive baseline surveys in 2017 and 2018. Otherwise, there were no notable differences in aquatic habitat between the baseline surveys and the supplementary site inspection (Figure 4.5).

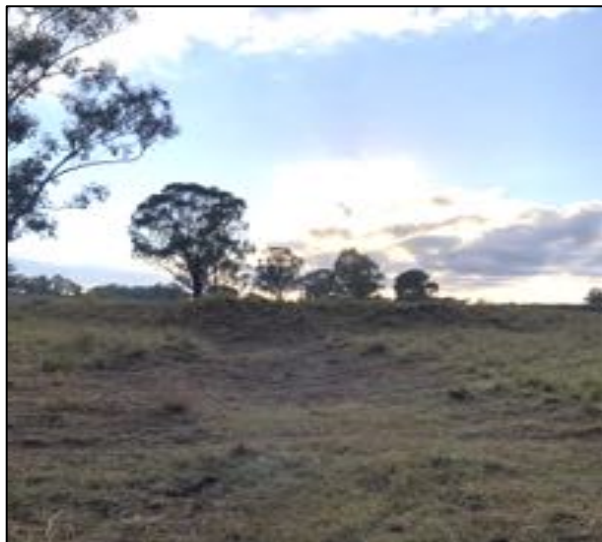
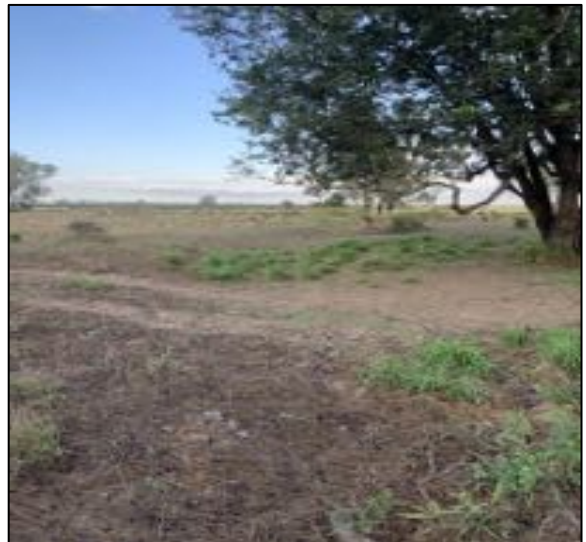
Figure 4.6 Green mapped waterway Tributary 1 showing a) upstream towards the dam wall and b) downstream from site T1-D1.

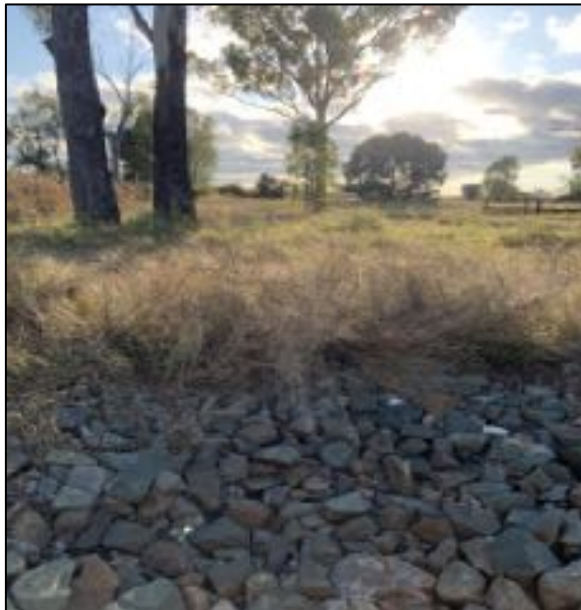
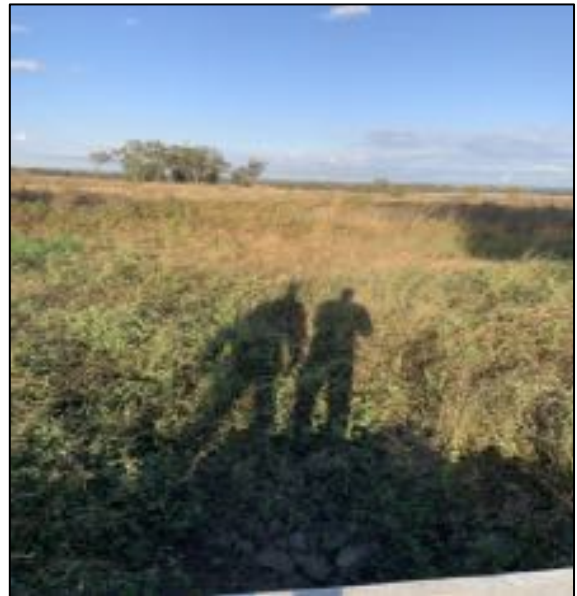
Figure 4.7 Green mapped waterway Tributary 2 showing a) upstream and b) downstream from site T2-D1.

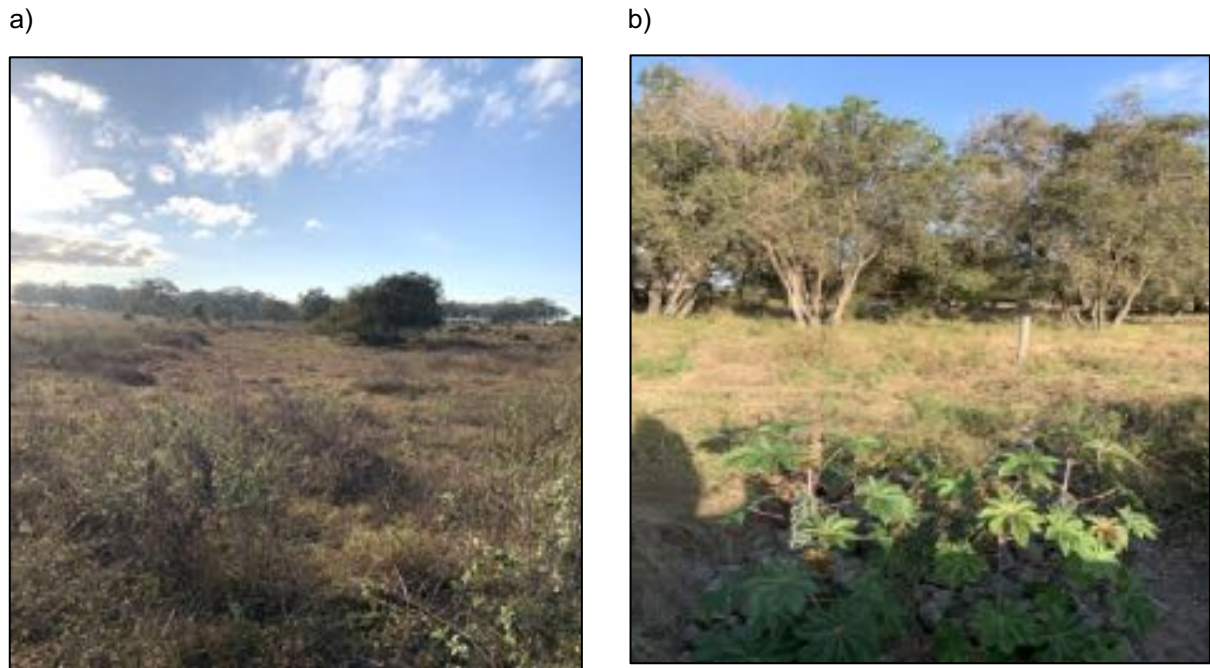
Tributary 3 at and upstream of site T3-D1 does not have the characteristics of a waterway for fish passage. It is unlikely that the construction of the ETL would have direct impacts on this feature.

Figure 4.8 Green mapped waterway Tributary 3 showing a) upstream and b) downstream from site T3-D1.

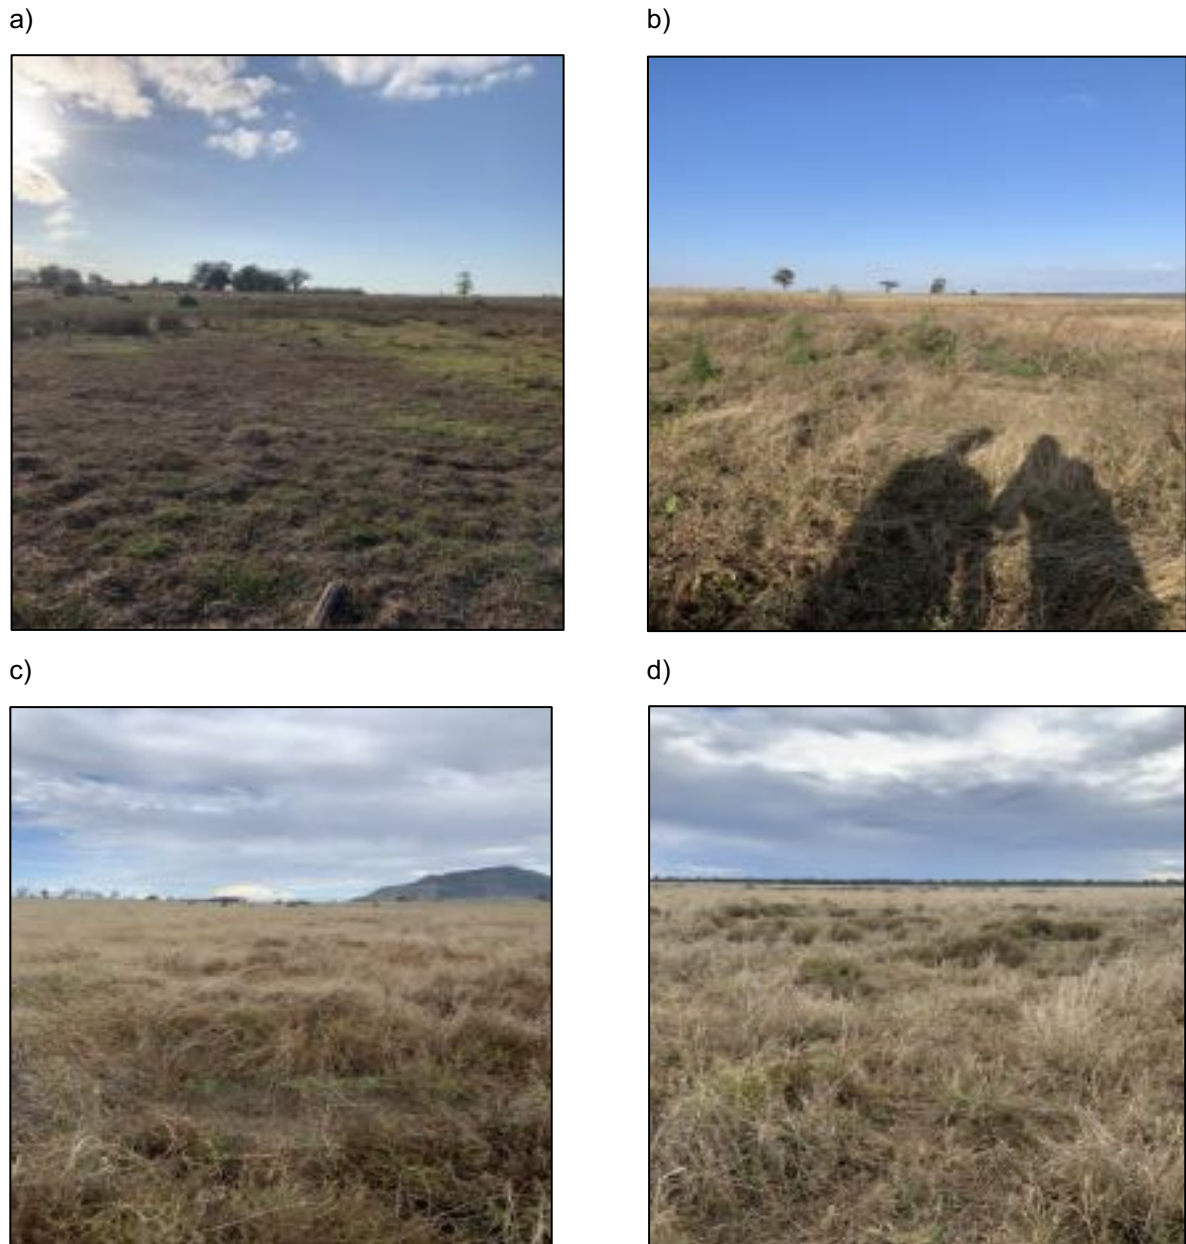
Figure 4.9 Green mapped waterway Tributary 4 showing a) upstream from site T4-D1; b) downstream from site T4-D1; c) upstream from site T4-D2 and; d) downstream from site T4-D2.

Downstream of Moura-Baralaba Road towards T4-D2 (i.e. within the proposed disturbance footprint), the tributary is indistinct within the paddock. Likewise, there was flat pasture at site T4-D2 and there was no indication of a waterway within the immediate area. There was no waterway feature present that would provide connectivity to other fish habitats. Upon review of topographical data and aerial photos, the area surrounding Tributary 4 appears to have been heavily modified from historical and current agricultural land uses. While there are sections of the mapped feature that resemble a relict channel, these sections are erosional features that lack riparian vegetation and are disconnected (isolated) from downstream waterways by flat floodplain and gilgai habitat (that lacks a distinct channel). That is, there are no continuous bed and banks along the mapped feature. Due to this, and the lack of flow adequacy to sustain basic ecological processes as described above, Tributary 4 does not have the characteristics of a waterway for fish passage (Figure 4.14).

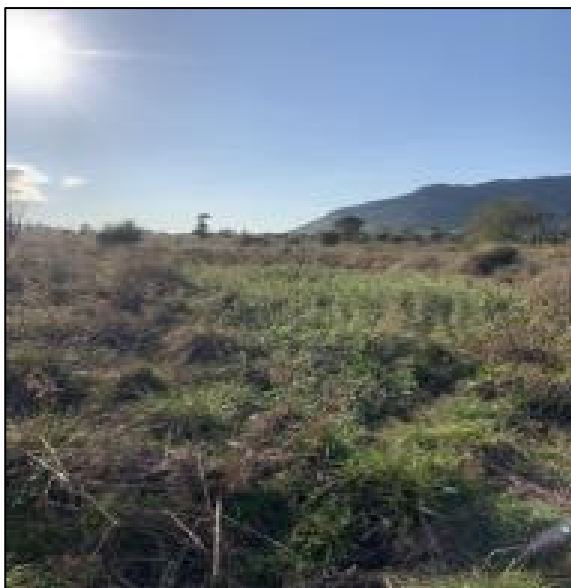
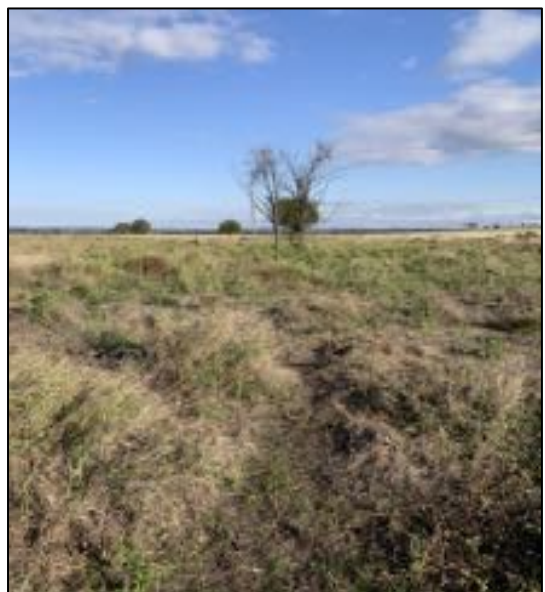
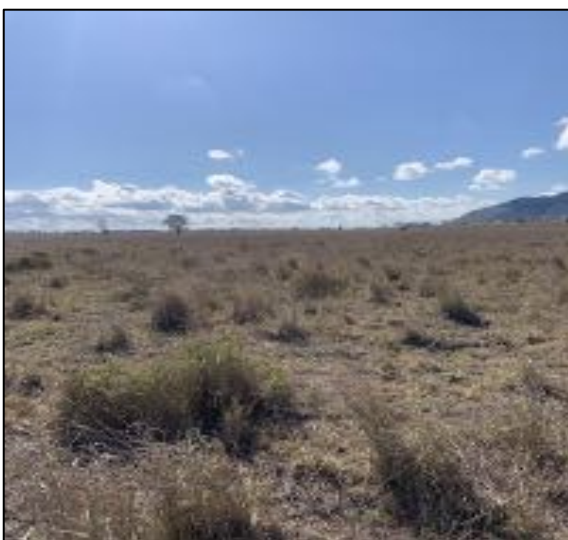
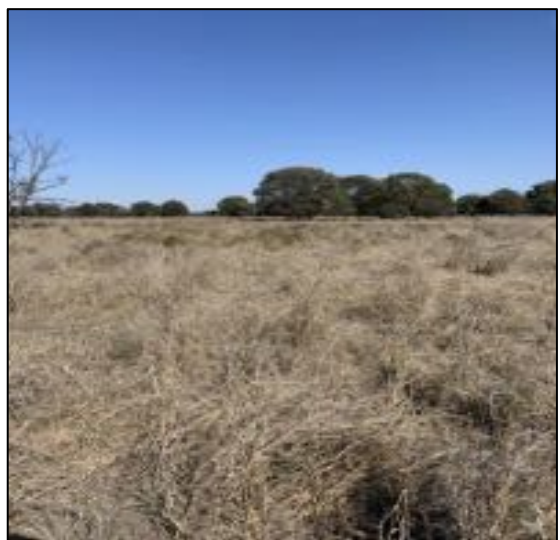
Figure 4.11 Tributary 6 showing a) green mapped section, upstream from site T6-D1; b) green mapped section downstream from site T6-D1; c) amber mapped section, upstream of T6-D3 and; d) amber mapped section, downstream of T6-D3.

Tributary 6 is within the proposed mine disturbance footprint, and is mapped as green (low risk of impact) at its headwaters and mapped as amber (moderate risk of impact) downstream of the confluence with Tributary 5 on the WWBW spatial layer (Figure 2.3). The headwaters of Tributary 6 at site T6-D1 are immediately upstream of a constructed farm dam, and the channel is ill-defined without bed and banks, and overgrown with terrestrial grasses (Figure 4.11). Further downstream towards sites T6-D2 and T6-D3, there is no feature present and there is no distinction between the mapped feature and the surrounding paddocks (Figure 4.11).

Tributary 6, along its entirety, does not have the characteristics of a waterway for fish passage.

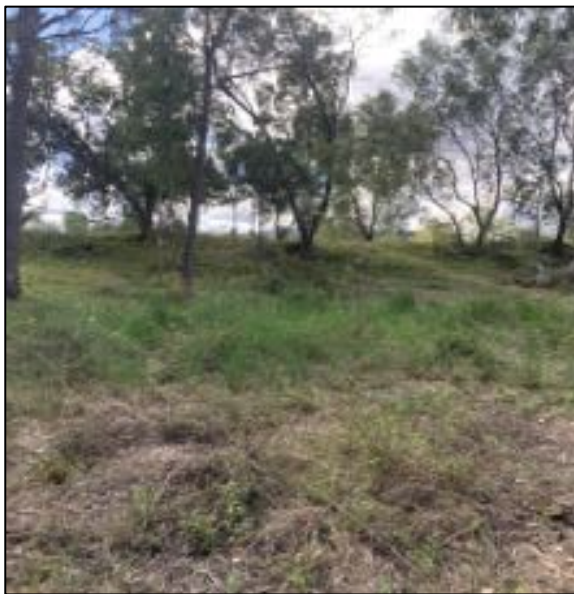
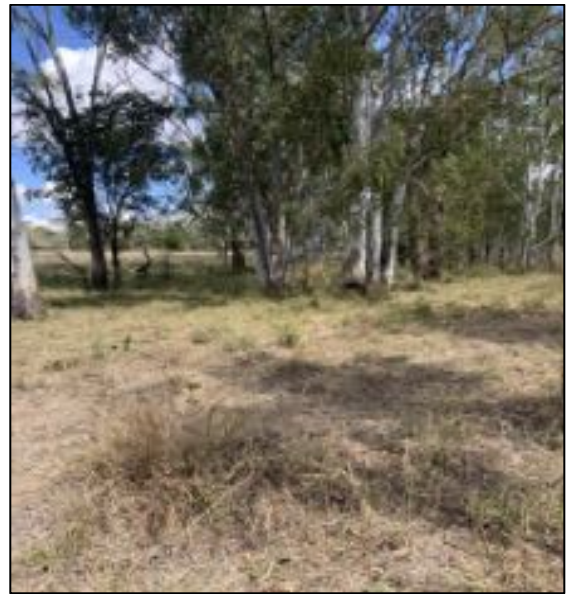
Figure 4.12 Green mapped waterway Tributary 7 showing a) upstream towards the farm dam wall and b) downstream from site T7-D1.

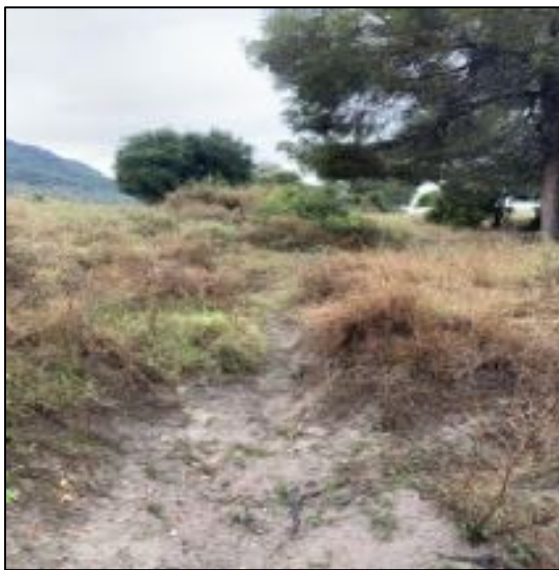
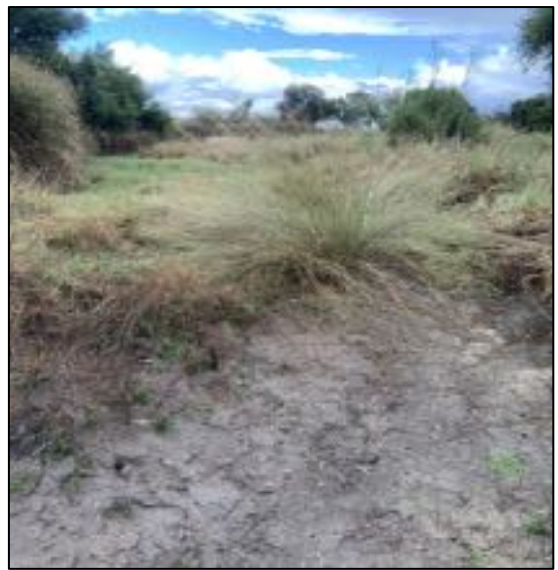
Figure 4.13 Tributary 8 showing a) green mapped section, upstream from site T8-D1; b) green mapped section downstream from site T8-D1; c) red mapped section, upstream of T8-D7 and d) red mapped section, downstream of T8-D7.

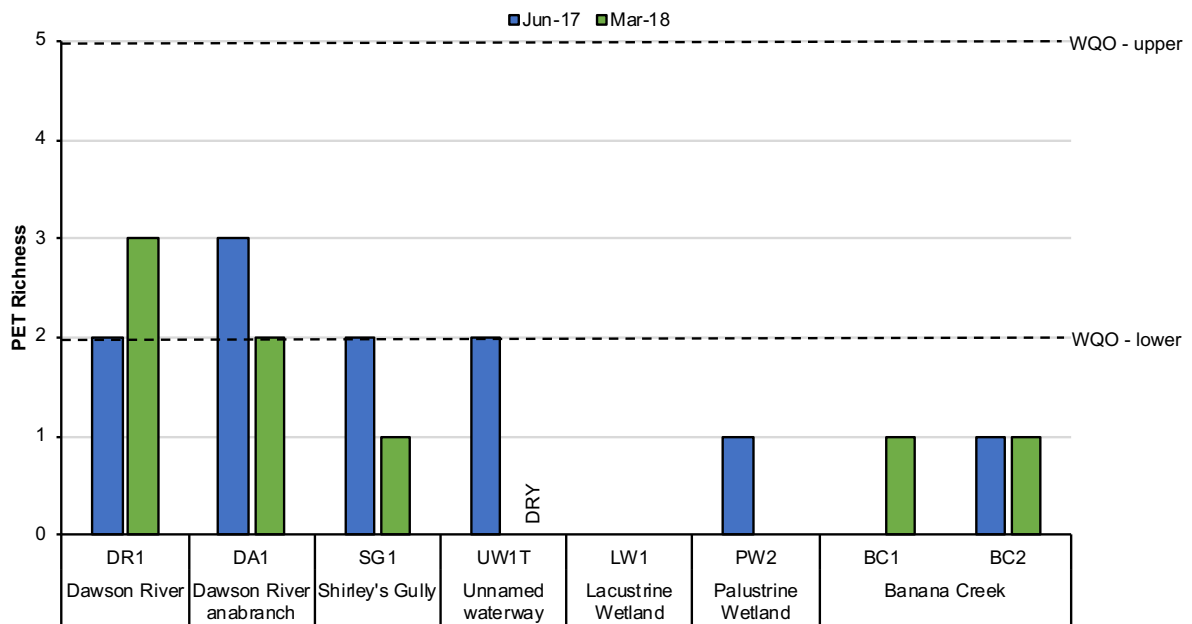
Figure 4.19 PET richness for bed habitat at each site.

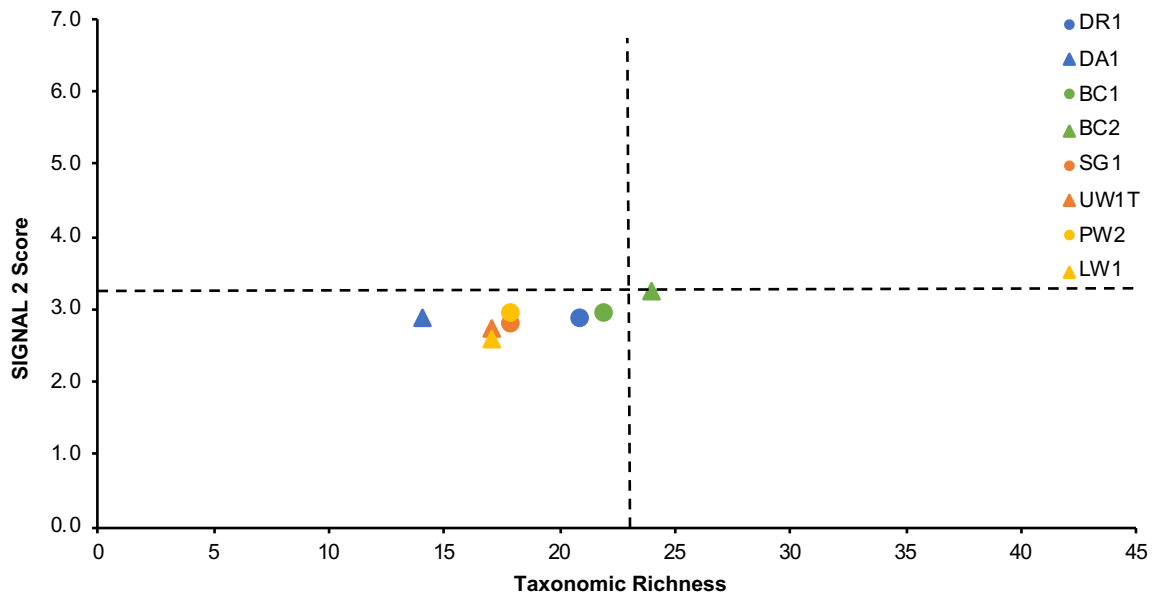
Figure 4.21 Signal 2 Bi-plot for edge habitat for each site in June 2017.

On SIGNAL 2 / family bi-plots for macroinvertebrate communities in edge habitat, most sites fell within Quadrant 4 in both surveys (site conditions are likely influenced by urban industrial or agricultural pollution) except for site BC2 in June 2017 and DA1 in March 2018, which were placed in Quadrant 2 (indicative of high concentrations of nutrients and/or high turbidity and salinity) (Figure 4.11 and 4.12). Water quality data supports this, with high concentrations of nutrients recorded at all sites, which is typical of waterways surrounded by agricultural land, and although electrical conductivity was low across all sites, turbidity was high and particularly high at site BC2 in June 2017 and site DA1 in March 2018.

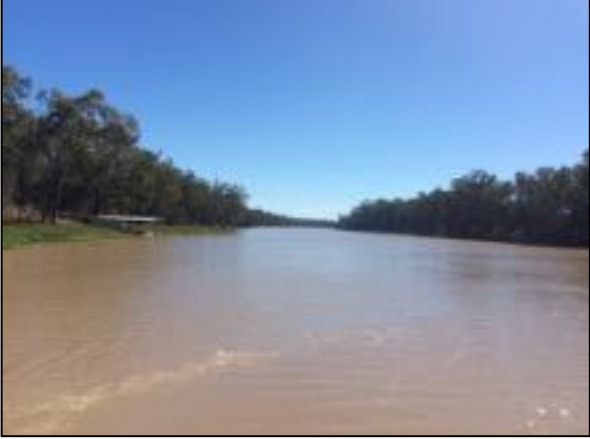
Site Photographs	Site Description
<p>DR1</p>

<p>Downstream March 2018</p>	<p>This site was located on the Dawson River downstream of the Project area. The Dawson River is identified as a watercourse under the Water Act and is classified as a stream order 8 waterway. This reach of the Dawson River is within the Neville Hewitt Weir impoundment area. The site was characterised as a wide and deep permanent waterway (wetted width 90-100m, depth >10m). The Dawson River experiences consistent flows throughout the year as it obtains inflow from groundwater sources throughout its length.</p> <p>In-stream habitat comprised of:</p> <ul style="list-style-type: none"> • deep pools • substrate dominated by fine sediments (silt and clay, some sand) • inundated trees and submerged and emerging logs and branches • sparse coverage of floating aquatic plants, and • overhanging and trailing bank vegetation fringing the edges.

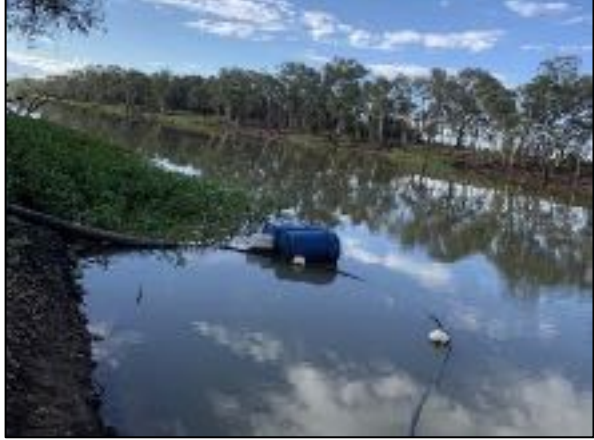
<p data-bbox="240 741 539 770">Downstream August 2023</p>	<p data-bbox="863 293 1437 510">In comparison to the March 2018 survey, little change was observed at the site. During the August 2023 site inspection, the field team observed that the water clarity had improved, which is likely to be related to lower rainfall prior to the site inspection and a reduction of sedimentation from upstream in the catchment. Overall, the aquatic ecological value of this site did not change.</p>

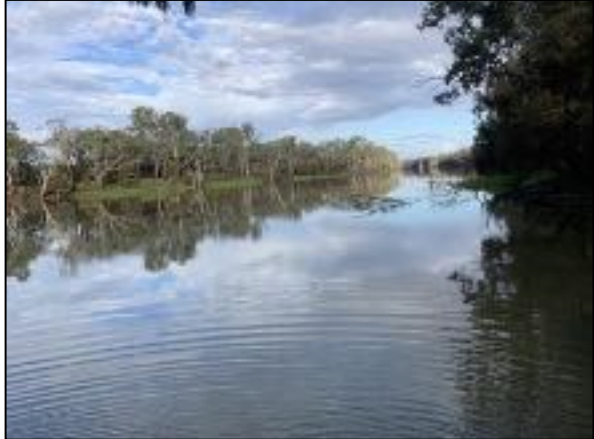
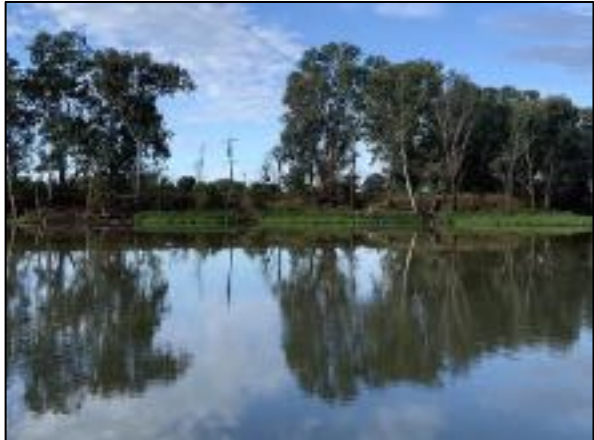
<p data-bbox="240 1267 507 1296">Upstream August 2023</p>

<p data-bbox="240 1794 815 1854">Fringing and trailing vegetation on the right bank: August 2023</p> <p data-bbox="240 1861 847 1944">Note: Photographs were taken from the western bank during the August 2023 surveys, as the eastern bank was inaccessible by foot.</p>

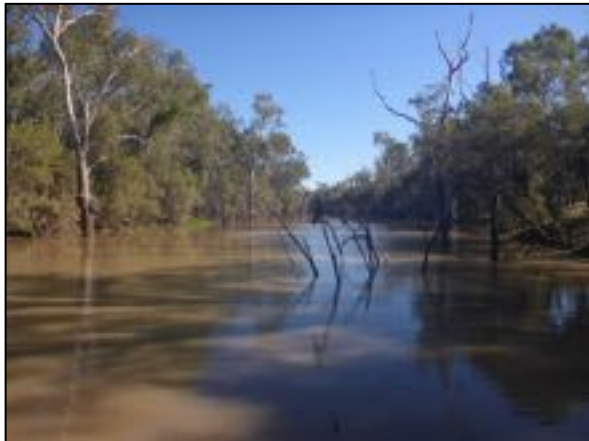
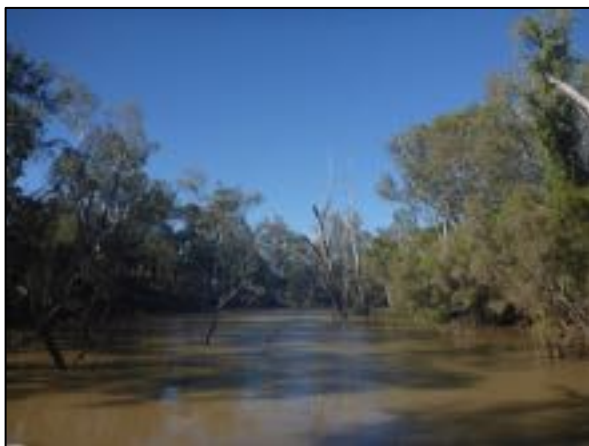
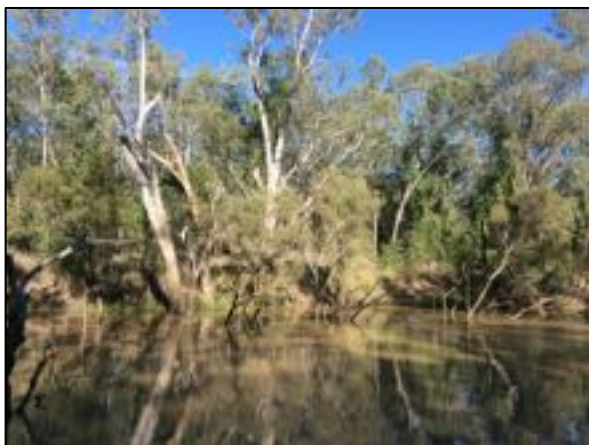
DA1

Downstream June 2017

Upstream June 2017

Left bank showing riparian vegetation: June 2017

This site was located on an anabranch of the Dawson River downstream of the Project area. The anabranch is identified as a watercourse under the Water Act and is classified as a stream order 8 waterway. It is located within the Neville Hewitt Weir impoundment area and is mapped as a lacustrine wetland. The Anabranch was characterised as a wide and deep permanent waterway (wetter width 20-30m, depth 5-7m). The anabranch comprises run habitat during flow periods and pool habitat during low to no flow periods.

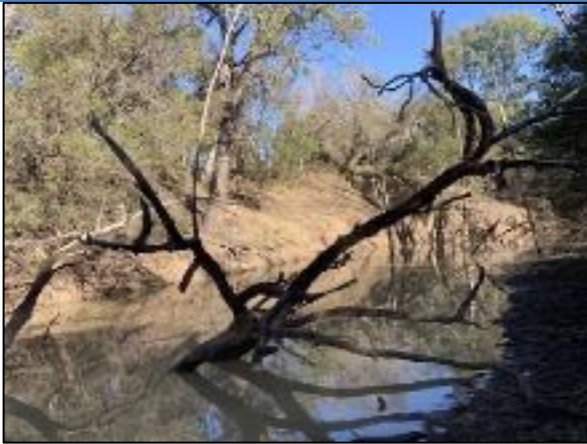
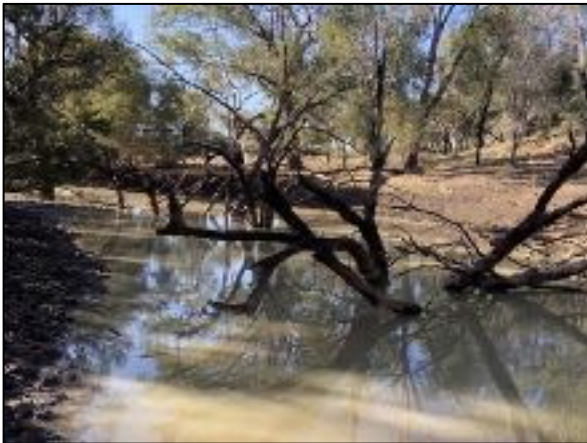
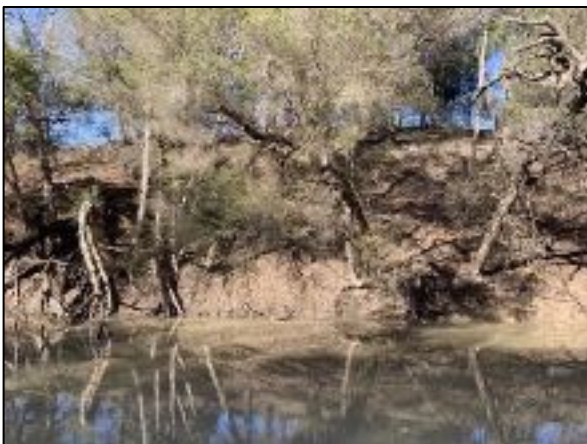
Downstream August 2023

Upstream August 2023

Left bank showing riparian vegetation: August 2023

The site was characterised as a narrowed and shallow waterway (wetted width 10-15m, depth 1-2m) when compared to previous surveys. Despite the lowered water levels, complex habitat features were still present within the site and around the edges and were considered suitable to support a variety of aquatic fauna. Overall, the aquatic ecological value of this site did not change.

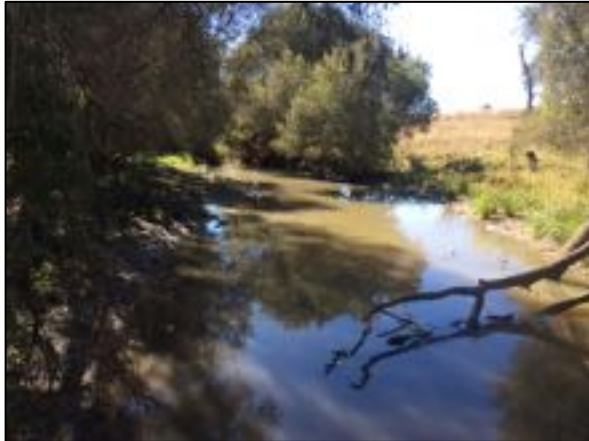
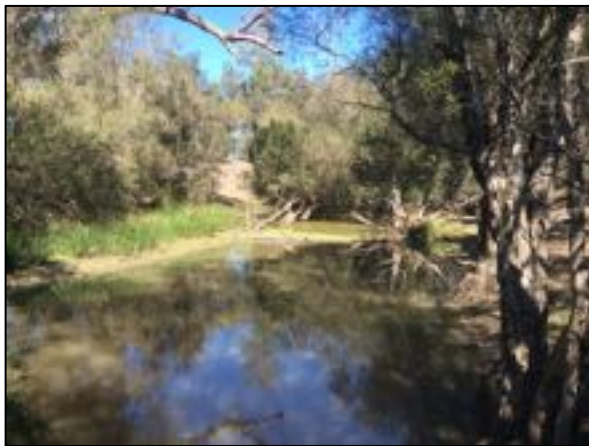
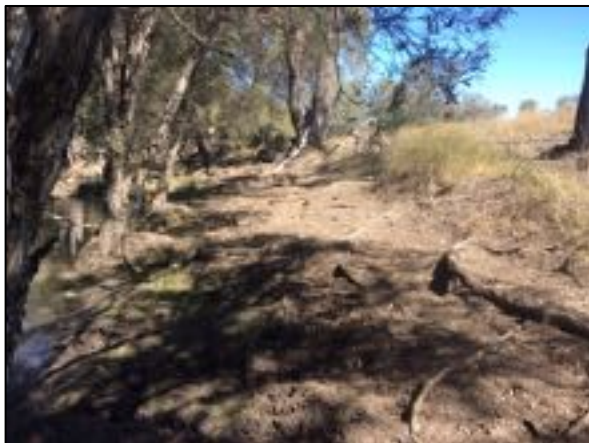
SG1

Downstream June 2017

Upstream June 2017

Reduced riparian vegetation on the right bank: June 2017

This site was located at the downstream extent of the unknown waterway that flows through the Project area, which is locally referred to as Shirley's Gully and is downstream of the Project area and approximately 700 m upstream of the waterway's confluence with the Dawson River Anabranch. Shirley's Gully is classified as a stream order 3 waterway and the lower reaches are identified as a watercourse on the WIM. The site was characterised as a wide permanent waterway (wetted width approximately 15m, depth 1.5m-2m). This reach of the unnamed waterway commonly receives backflow from the Anabranch during periods of high flow and high water levels within the Neville Hewitt Weir Pool.

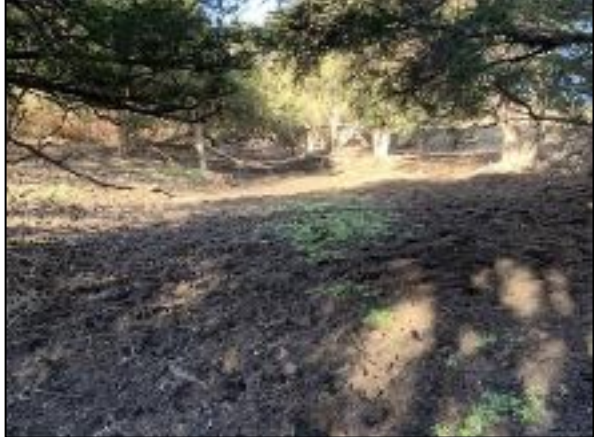
A photograph showing a dry, rocky stream bed with sparse green vegetation and trees in the background.	<p>aquatic fauna during significant rain events and high flows or at times when water levels in the Neville Hewitt Weir impoundment are higher (and water backs up into Shirley's Gully). Overall despite no water, the aquatic ecological value of the site did not appear to change.</p>

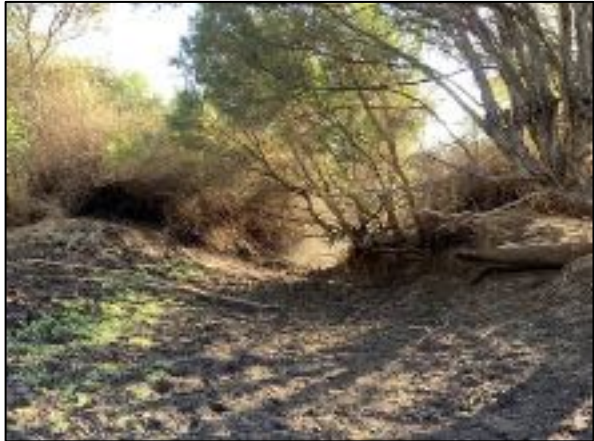
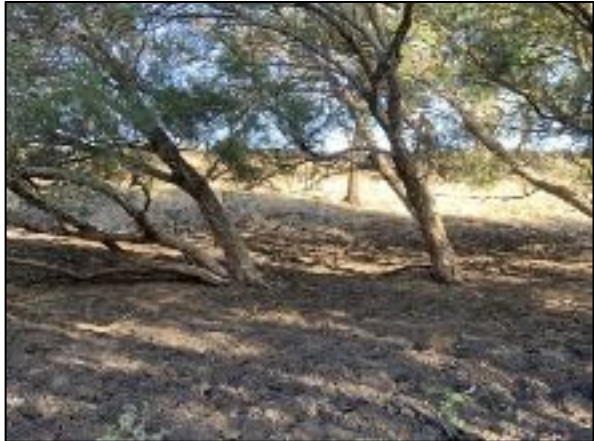
A photograph showing a dry, rocky stream bed with sparse green vegetation and trees in the background.

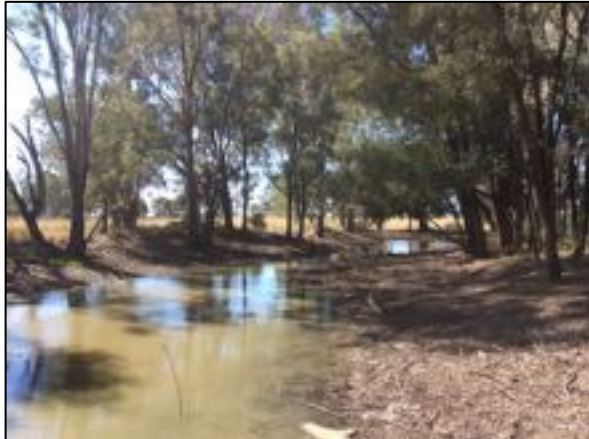
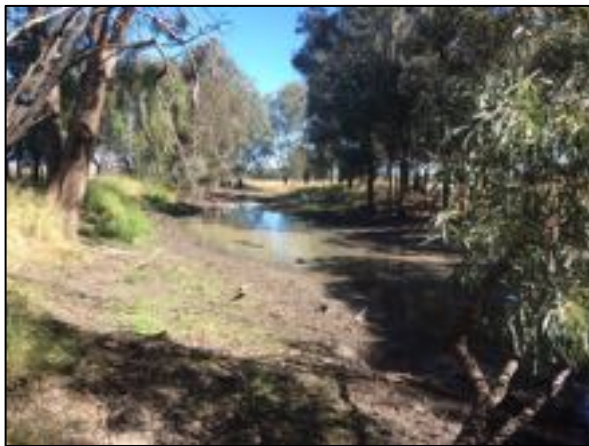
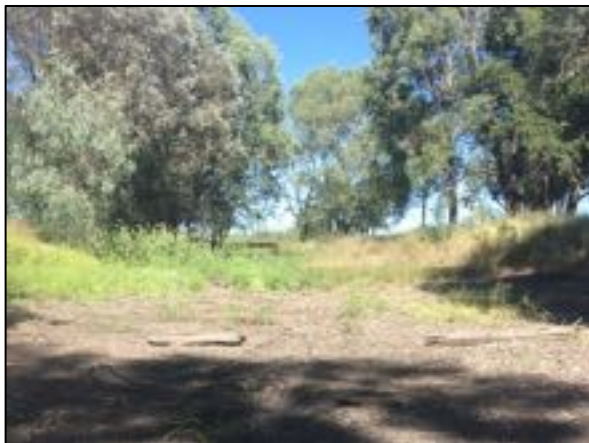
UW1T

Downstream June 2017

Upstream June 2017

Upstream March 2018

This site was located on a western tributary of Tributary 8 that flows through the Project area. The tributary is unmapped and is stream order 1 ephemeral drainage channel characterised as a shallow isolated pool in June 2017 but was dry in March 2018.

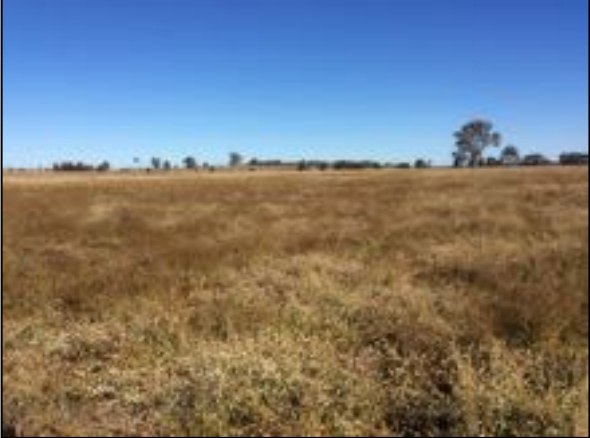
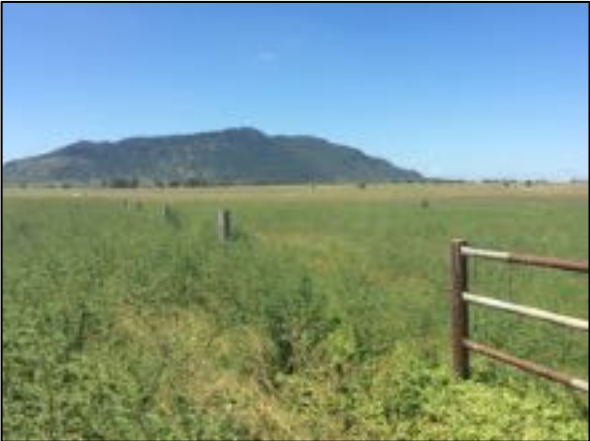
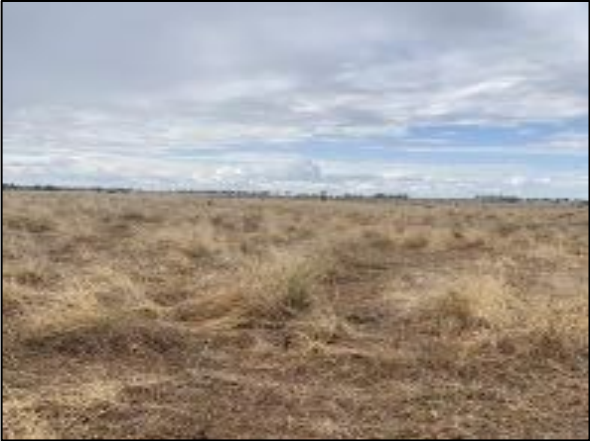
Site Photographs	Site Description
  <p data-bbox="240 741 539 770">Downstream August 2023</p>	
  <p data-bbox="240 1267 504 1296">Upstream August 2023</p>	
<p data-bbox="240 1323 300 1352">UW2</p>   <p data-bbox="240 1807 512 1836">Downstream June 2017</p>	<p data-bbox="879 1323 1442 1514">This site was located on Tributary 5 that flows through the Project area. The tributary is classified as a stream order 2 waterway and is a drainage feature on the WIM. The site was characterised as an overland flow area within the Dawson river flood plain that was dry in June 2017, March 2018 and August 2023.</p> <p data-bbox="879 1525 1442 1742">There were no defined bed or banks and no riparian vegetation. i.e. there was no channel discernible from the surrounding paddock. No in-stream aquatic habitat features were present; remnant and sparse patches of emergent wetland indicator plants (e.g. sedges and rushes) were present indicating the area has depressions that are periodically inundated to support the growth of aquatic plants.</p> <p data-bbox="879 1753 1442 1836">The area was a modified rural landscape that has been cleared for grazing and is vegetated by grasses only.</p> <p data-bbox="879 1848 1442 1989">Aquatic habitat condition was considered poor due to an overall lack of a waterway and aquatic habitat features. The site was not considered appropriate for listed aquatic species. The site and surrounds may be best characterised as gilgai habitat.</p> <p data-bbox="879 2000 1442 2056">The aquatic habitat value of the site was considered very low. There was a lack of a defined channel with</p>

<p>bed and banks. The site does not have any distinct habitat features to support a diversity of aquatic flora or provide any vital habitat for refuge or breeding.</p>
<p>Upstream June 2017</p>

<p>Upstream March 2018</p>

<p>Downstream August 2023</p>

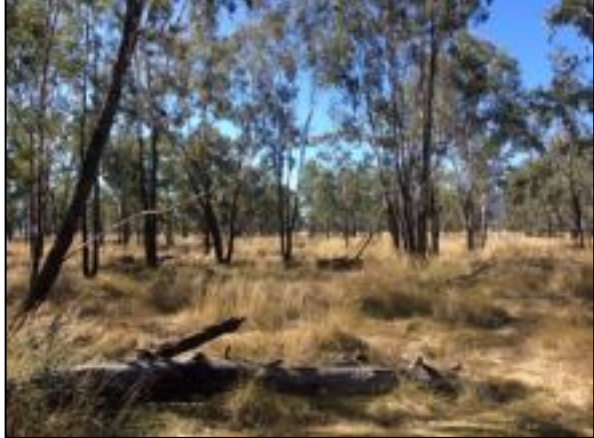
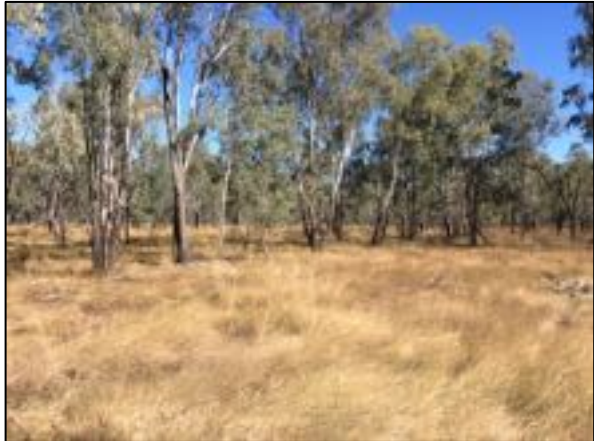
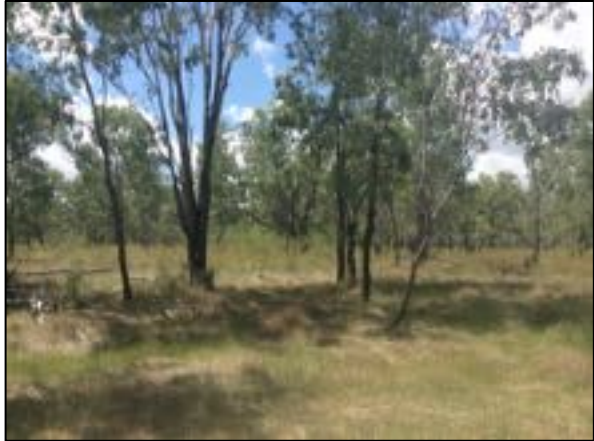
<p>flood plain. The site was dry in both June 2017 and March 2018.</p> <p>Features that would provide habitat in periods of inundation comprised:</p> <ul style="list-style-type: none"> • small and large woody debris and tree roots • substrate dominated by silt and clay • overhanging and trailing bank vegetation, and • macrophyte beds.
<p>North orientation June 2017</p>

<p>The riparian zone was in poor condition. The wetland is located in a modified rural landscape and vegetation has been cleared to the parameter of the wetland leaving no obvious riparian zone buffering the wetland. The wetland vegetation comprises an overstory of <i>Eucalyptus</i> sp. and <i>Acacia</i> sp. (Brigalow) and extensive beds of dry aquatic plants comprised the groundcover.</p>
<p>South orientation June 2017</p>

<p>South orientation March 2018</p>	<p>Habitat condition of the site was considered fair. Although dry, the wetland provided habitat for aquatic flora, and during periods of inundation it would support some aquatic fauna (i.e. macroinvertebrates; it is unlikely to support fish or turtles due to poor connectivity). The site was not considered appropriate for listed species.</p> <p>Overall the aquatic habitat value of the site was considered low. The wetland does not support a large variety of aquatic flora and would rarely be able to support aquatic fauna due to its ephemeral nature and poor connectivity.</p> <p>In comparison to the June 2017 and March 2018 surveys, conditions were drier in August 2023. The overall aquatic ecological value of the site did not appear to change.</p>

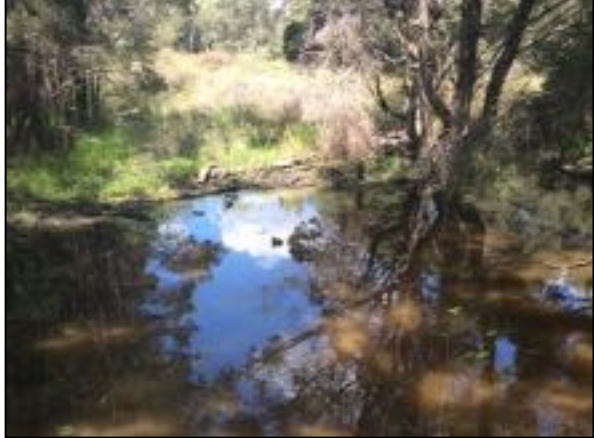
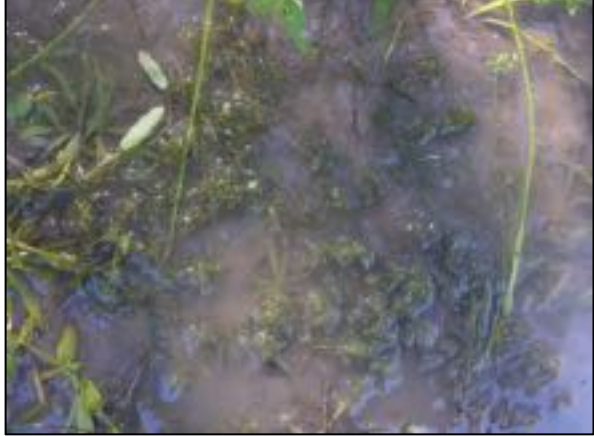
<p>The wetland is located in a modified rural landscape and vegetation has been cleared to the parameter of the wetland leaving no obvious riparian zone buffering the wetland. The wetland vegetation has been historically cleared but is comprised of native regrowth in good condition, including <i>Melaleuca</i> sp. with some <i>Eucalyptus</i> sp. (Coolibah) and <i>Acacia</i> sp. and stands of <i>Duma</i> sp..</p> <p>The habitat conditions was considered fair. The wetland supported a variety of aquatic flora and long lasting pools but lacked overall habitat diversity and connectivity. The site was not considered appropriate for listed species.</p>
<p>Wetted pool March 2018</p>

<p>Overall the aquatic habitat value was considered low. The wetland does support a variety of aquatic flora, however it does not support a diversity of fauna. Its disconnected nature and high level of disturbance makes it unsuitable for listed species and it is not considered to provide distinct or vital habitat for aquatic flora or fauna in the region.</p>

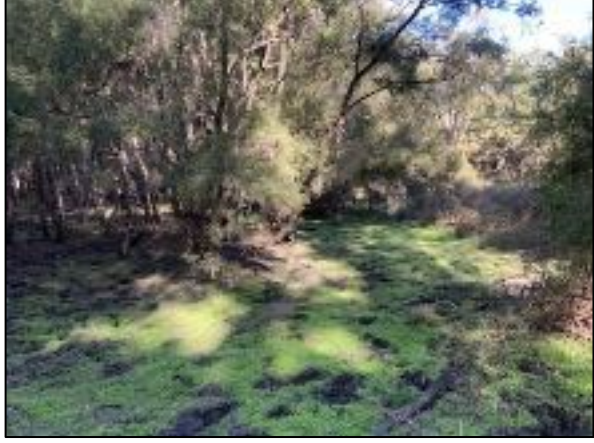
<p>Variety of aquatic plants growing in wetted pool: June 2017</p>	<p>The wetland was dry (though the pool had only recently dried up) in August 2023, confirming that while pools in the wetland are long-lasting, they are not perennial. The aquatic ecological value of the site did not change.</p>

<p>Recently dry bed in August 2023</p>
