Baralaba South Project EIS

Aquatic Ecology Assessment Report

Prepared for: Baralaba South Pty Ltd

Prepared by: Ecological Service Professionals Pty Ltd

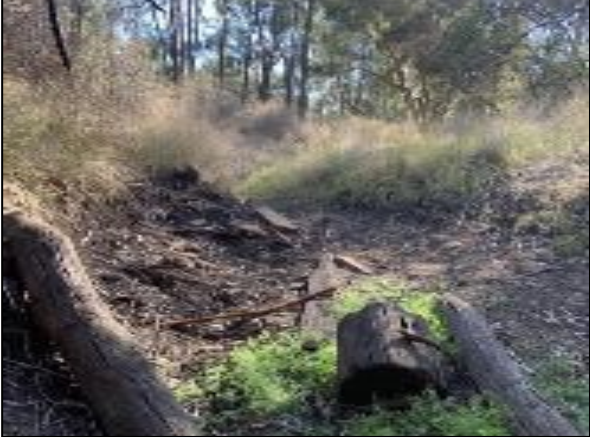
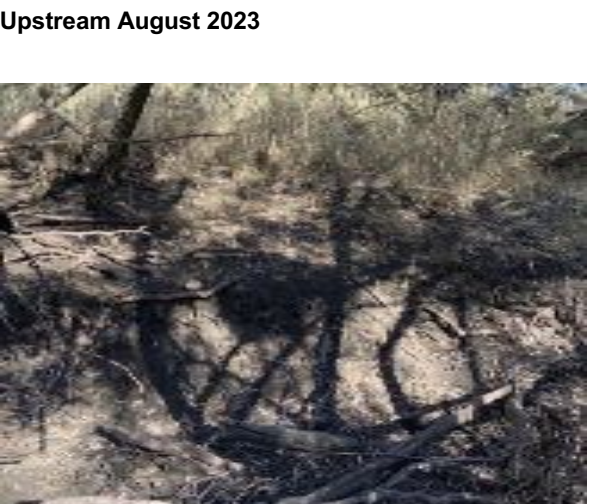
<p>A photograph showing a streambed with large logs and debris, surrounded by dense vegetation and trees.</p>	
<p>Downstream August 2023</p>

<p>A photograph showing a streambed with large logs and debris, surrounded by dense vegetation and trees.</p>	
<p>Upstream August 2023</p>	
<p>A photograph showing a dry pool with woody debris and overhanging vegetation.</p>	
<p>Dry pool with woody debris and overhanging vegetation: August 2023</p>

<p data-bbox="240 1794 754 1854">Backwater pool with large woody debris and overhanging vegetation: March 2018</p>	<p data-bbox="863 1435 1442 1572">Overall the aquatic ecological value of the site was considered high. The reach would provide consistent available habitat for refuge and breeding as well as connectivity to other areas for a variety of aquatic fauna, including listed species.</p> <p data-bbox="863 1583 1442 1883">In comparison to the June 2017 and March 2018 surveys, the site was dry in August 2023. This is likely to be related to rainfall prior to the survey and lower water levels in the Neville Hewitt weir pool. Despite the dry conditions, complex habitat features were still present within the site and around the edges and were considered suitable to support a variety of aquatic fauna. The aquatic ecological value of the site was downgraded to moderate, due to the lack of permanent pools that were considered likely to occur during the baseline assessments.</p>

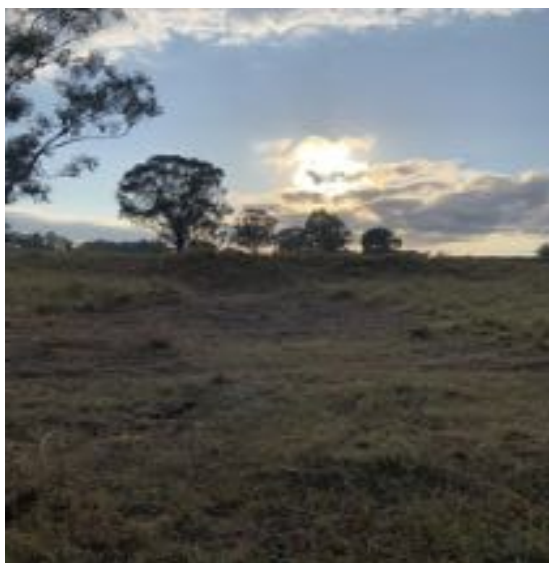
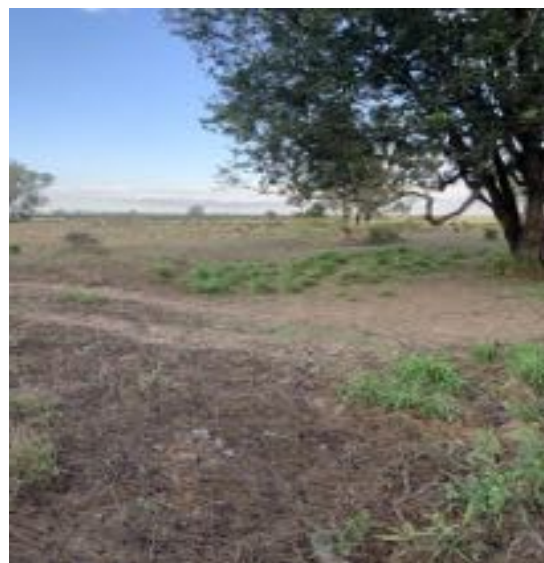
Figure 8.1 Determination 1 at Tributary 1 showing a) upstream, and b) downstream

Is the feature a waterway providing for fish passage?	No	
Low flow channel width	N/A	
Main channel width	N/A	
Fullbank width	N/A	
Main channel bank height	L: N/A	R: N/A
Fullbank bank height	L: N/A	R: N/A

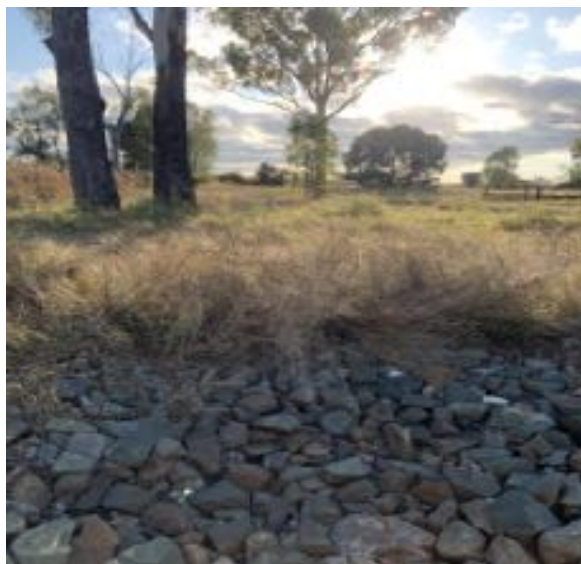
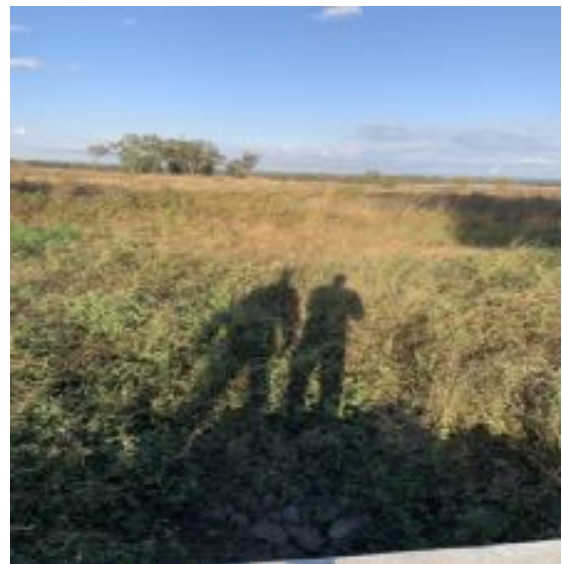
Figure 8.2 Determination 1 at Tributary 2 at showing a) upstream, and b) downstream

Defined bed and banks:	No defined or continuous bed and banks present.	
Extended period of flow:	Indication that the feature likely flows for at least short periods during extended rainfall, due to the presence of two pipe culverts (approximately 30 cm each), running underneath the road.	
Adequate flow:	Upstream of T2D1, the feature represents a small depression that likely channels localised flow during high rainfall events. Downstream of T2D1, the feature was non-existent. Downstream and upstream is severely limited for fish passage.	
Habitat features:	No aquatic plants or fish habitat features present.	
Is the feature a waterway providing for fish passage?	No	
Low flow channel width	N/A	
Main channel width	N/A	
Fullbank width	N/A	
Main channel bank height	L: N/A	R: N/A
Fullbank bank height	L: N/A	R: N/A

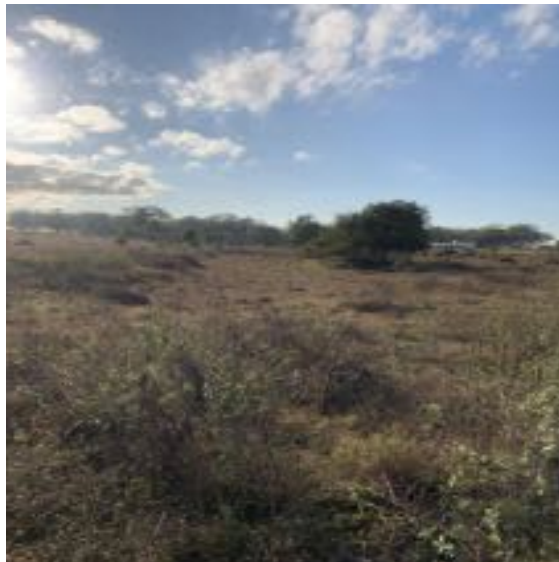
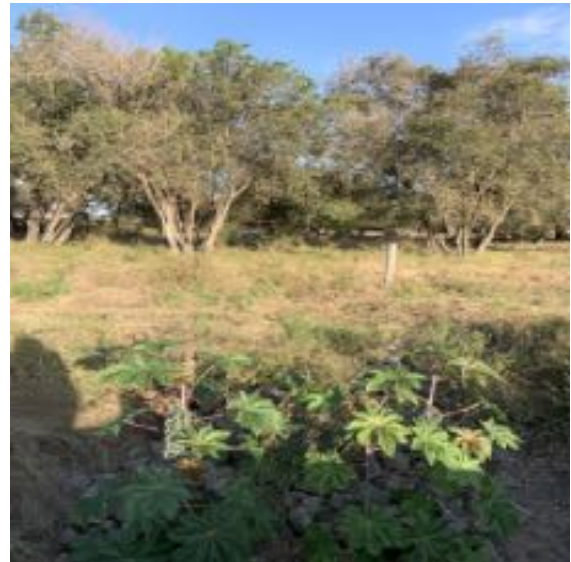
Figure 8.3 Determination 1 at Tributary 3 showing a) upstream, and b) downstream

Defined bed and banks:	No defined or continuous bed and banks present.	
Extended period of flow:	Significant pipe culverts under road suggests feature flows hard and fast after rain but likely would not hold any water for extended periods.	
Adequate flow:	Upstream of site T3-D1, the feature represents a wide flat channel that likely pools overland flow during rainfall events. However, downstream the feature was small, narrow and overgrown by terrestrial grasses suggesting that flow, if any, is limited and highly intermittent.	
Habitat features:	No aquatic plants or fish habitat present.	
Is the feature a waterway providing for fish passage?	No	
Low flow channel width	N/A	
Main channel width	N/A	
Fullbank width	N/A	
Main channel bank height	L: N/A	R: N/A
Fullbank bank height	L: N/A	R: N/A

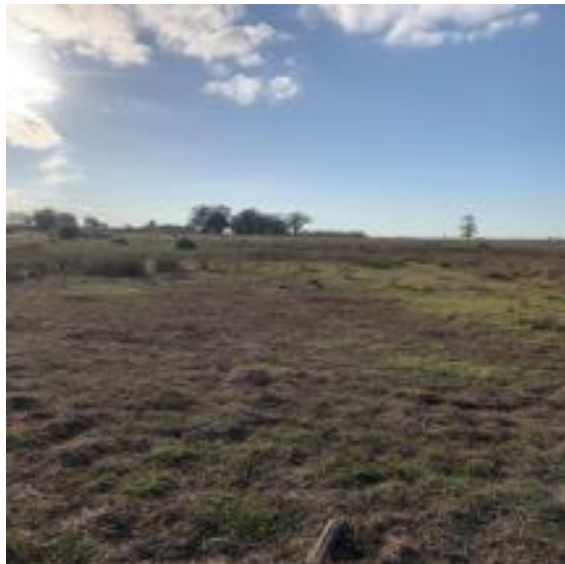
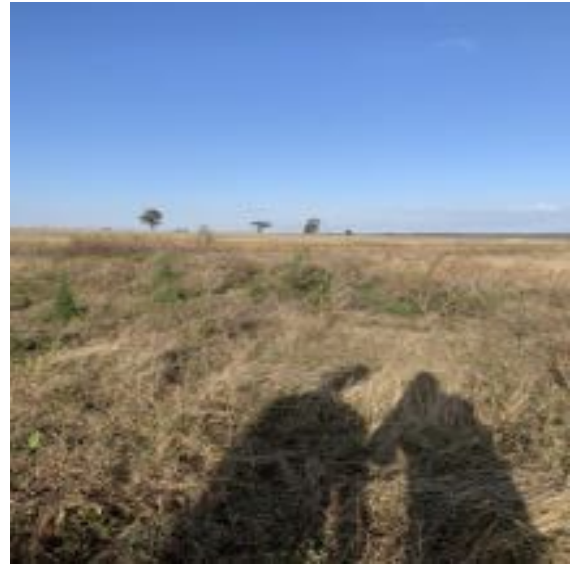
Figure 8.4 Determination 1 at Tributary 4 showing a) upstream, and b) downstream

Defined bed and banks:	No defined or continuous bed and banks present.	
Extended period of flow:	Located immediately downstream from a constructed farm dam and would likely only receive overflow during periods of high rainfall. This feature is unlikely to sustain flows for extended periods.	
Adequate flow:	Wide, flat drainage channel downstream from a constructed farm dam. Dam walls are about 3m high and would likely only spill over in high rainfall events.	
Habitat features:	Aquatic plants present in a flattened area directly upstream from road, which likely pools water for short periods. No fish habitat present.	
Is the feature a waterway providing for fish passage?	No	
Low flow channel width	N/A	
Main channel width	N/A	
Fullbank width	N/A	
Main channel bank height	L: N/A	R: N/A
Fullbank bank height	L: N/A	R: N/A

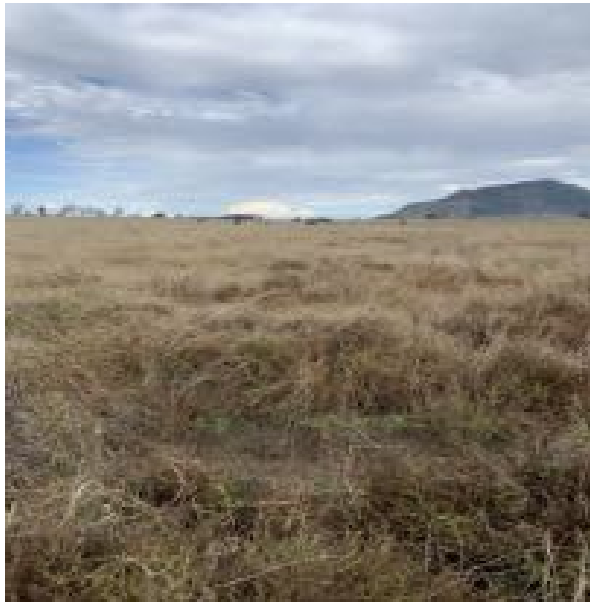
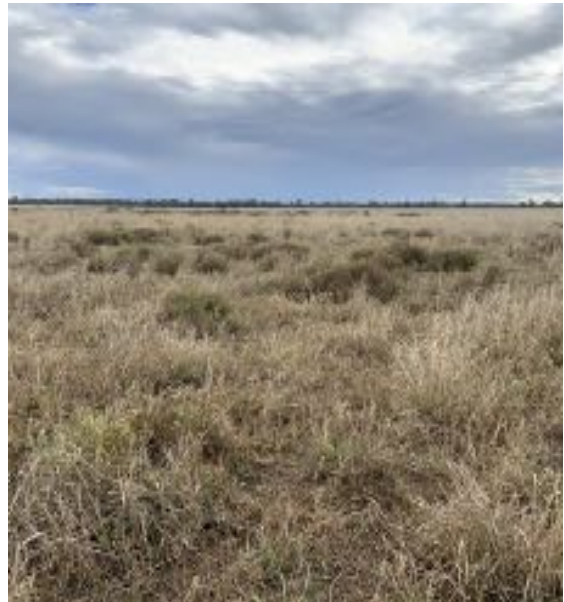
Figure 8.5 Determination 2 at Tributary 4 showing a) upstream, and b) downstream

Defined bed and banks:	No defined or continuous bed and banks present.	
Extended period of flow:	Unlikely to provide extended periods of flow.	
Adequate flow:	Unlikely to provide adequate flow to sustain basic ecological processes.	
Habitat features:	No aquatic plants or fish habitat features were present.	
Is the feature a waterway providing for fish passage?	No	
Low flow channel width	N/A	
Main channel width	N/A	
Fullbank width	N/A	
Main channel bank height	L: N/A	R: N/A
Fullbank bank height	L: N/A	R: N/A

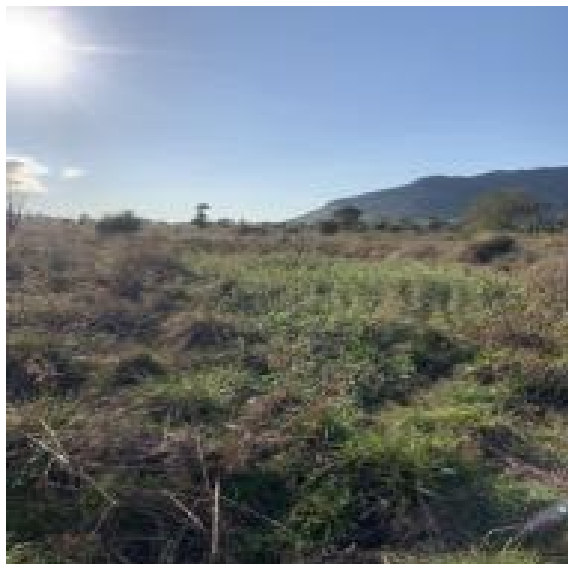
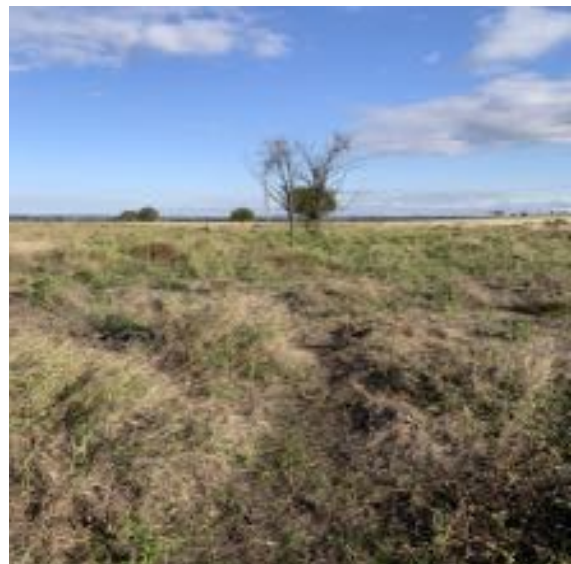
Figure 8.6 Determination 1 at Tributary 5 showing a) upstream, and b) downstream

Defined bed and banks:	No defined or continuous bed and banks present.	
Extended period of flow:	Tributary 5 located immediately downstream from a constructed farm dam and would likely only receive overflow during periods of high rainfall. This feature is unlikely to sustain flows for extended periods.	
Adequate flow:	The presence of a dam upstream and the absence of culverts and a passage under the road downstream, suggests that adequate flow and fish passage is severely limited on this feature.	
Habitat features:	Aquatic plant species <i>Persicaria</i> and <i>Cyperus</i> present, indicating water intermittently pools within areas of the channel. No fish habitat present.	
Is the feature a waterway providing for fish passage?	No	
Low flow channel width	N/A	
Main channel width	N/A	
Fullbank width	N/A	
Main channel bank height	L: N/A	R: N/A
Fullbank bank height	L: N/A	R: N/A

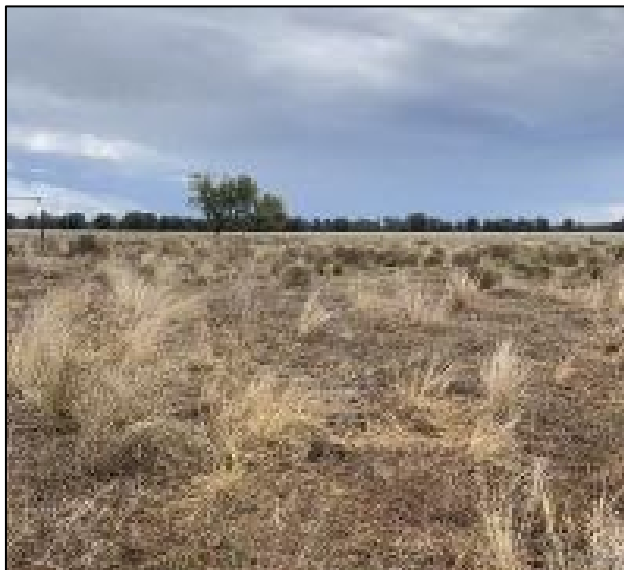
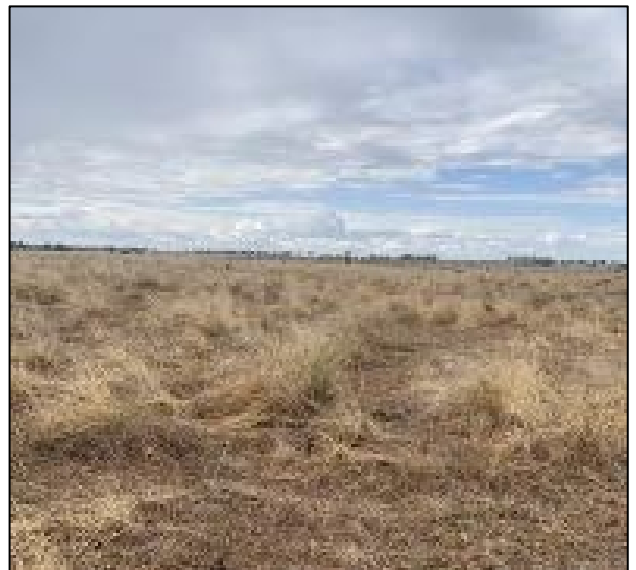
Figure 8.7 Determination 2 (UW2) at Tributary 5 showing a) upstream, and b) downstream

Defined bed and banks:	No defined or continuous bed and banks present.	
Extended period of flow:	No evidence of an extended period of flow.	
Adequate flow:	No evidence of adequate flow.	
Habitat features:	No aquatic plants, or fish habitat present. The area surrounding the mapped feature was primarily flat pasture dominated by terrestrial grasses and weeds. The field team walked the surrounding area to find the feature, but could not find any evidence of a waterway.	
Is the feature a waterway providing for fish passage?	No	
Low flow channel width	N/A	
Main channel width	N/A	
Fullbank width	N/A	
Main channel bank height	L: N/A	R: N/A
Fullbank bank height	L: N/A	R: N/A

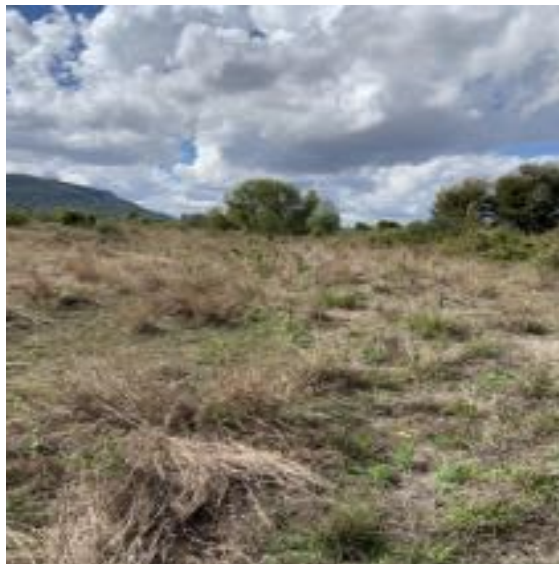
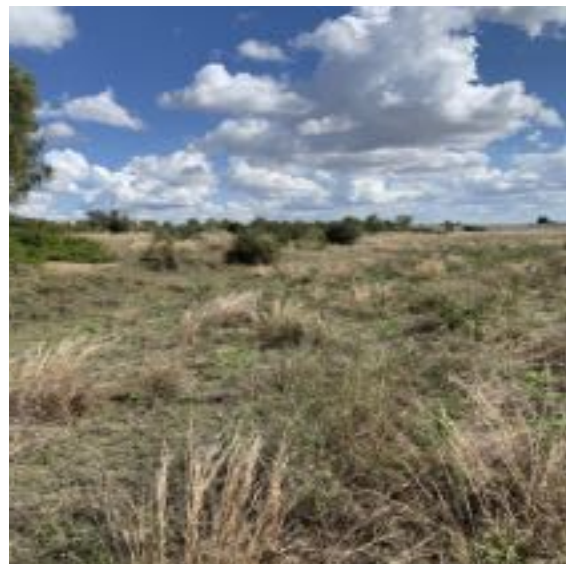
Figure 8.8 Determination 1 at Tributary 6 showing a) upstream, and b) downstream

Defined bed and banks:	No defined or continuous bed and banks present.	
Extended period of flow:	Would not flow for an extended period as there is no visible channel / feature and there is no distinction between the mapped feature and the surrounding paddocks.	
Adequate flow:	Flow not adequate to maintain aquatic ecological processes. No defined channel, riparian vegetation or aquatic plants.	
Habitat features:	Overgrown by terrestrial grass, likely channels overland flow into dam. No aquatic plants or fish habitat features, however there is likely to be fish in the dam downstream.	
Is the feature a waterway providing for fish passage?	No.	
Low flow channel width	N/A	
Main channel width	N/A	
Fullbank width	N/A	
Main channel bank height	L: N/A	R: N/A
Fullbank bank height	L: N/A	R: N/A

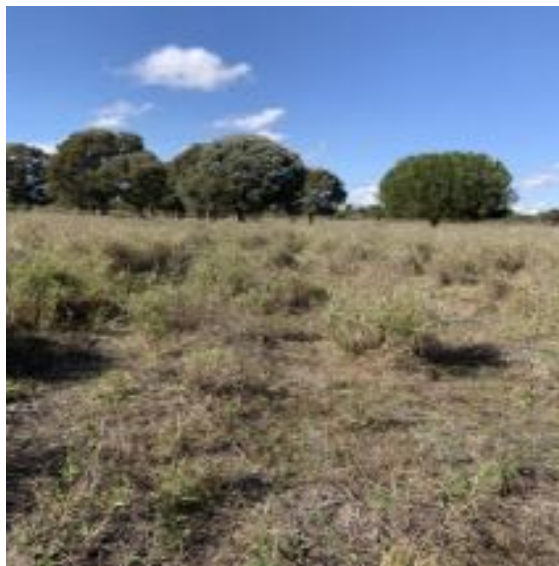
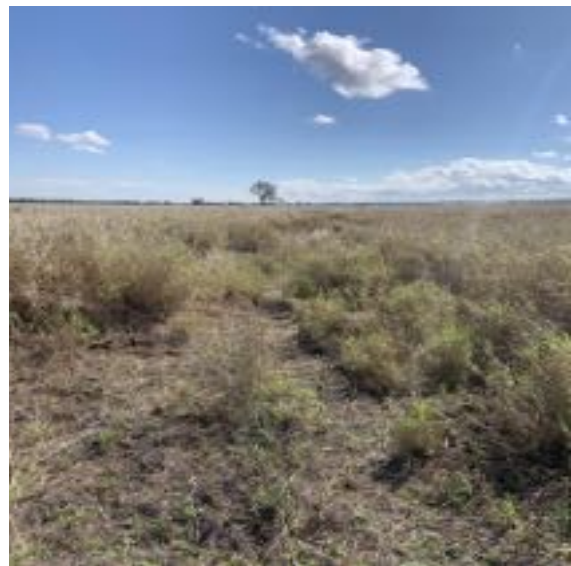
Figure 8.9 Determination 2 at Tributary 6 showing a) upstream, and b) downstream

Defined bed and banks:	No defined or continuous bed and banks present.	
Extended period of flow:	Does not flow for an extended period. The drainage corridor is full of terrestrial grasses and weeds, indicating a lack of extended flow.	
Adequate flow:	Small drainage feature likely channels overland flow from local catchment after heavy rainfall.	
Habitat features:	No aquatic plants or fish habitat features. Small drainage feature overgrown with terrestrial grasses and weeds.	
Is the feature a waterway providing for fish passage?	No	
Low flow channel width	N/A	
Main channel width	N/A	
Fullbank width	N/A	
Main channel bank height	L: N/A	R: N/A
Fullbank bank height	L: N/A	R: N/A

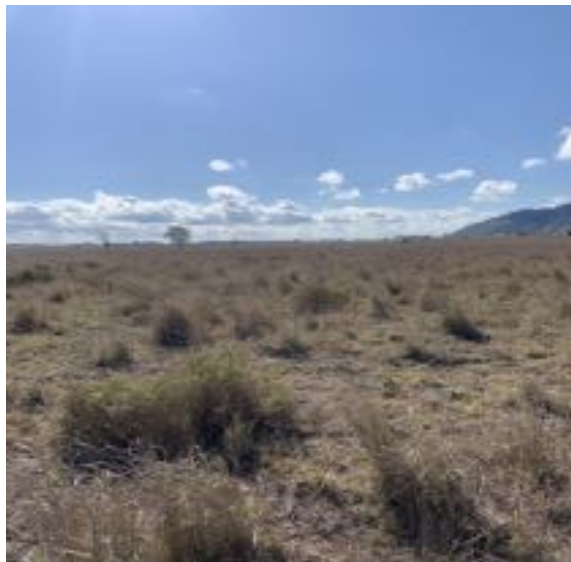
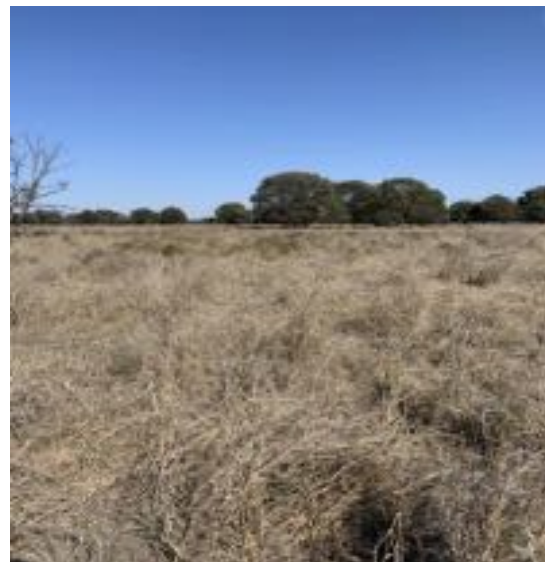
Figure 8.10 Determination 3 at Tributary 6 showing a) upstream, and b) downstream

Defined bed and banks:	No defined or continuous bed and banks present.	
Extended period of flow:	No feature present, and does not flow for an extended period.	
Adequate flow:	No feature present adequate to sustain basic aquatic ecological processes.	
Habitat features:	No aquatic plants or fish habitat features.	
Is the feature a waterway providing for fish passage?	No	
Low flow channel width	N/A	
Main channel width	N/A	
Fullbank width	N/A	
Main channel bank height	L: N/A	R: N/A
Fullbank bank height	L: N/A	R: N/A

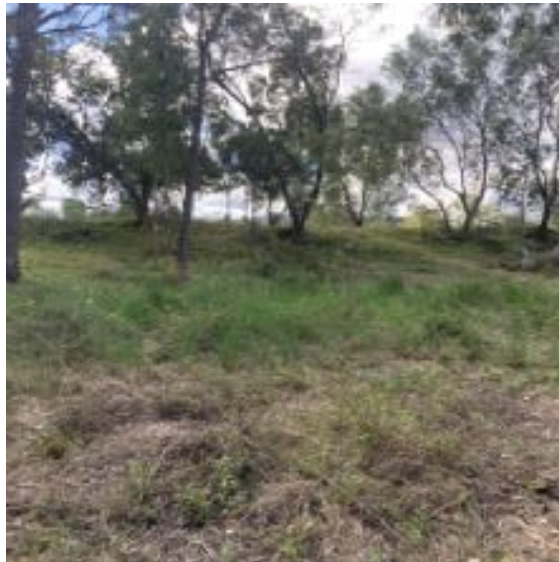
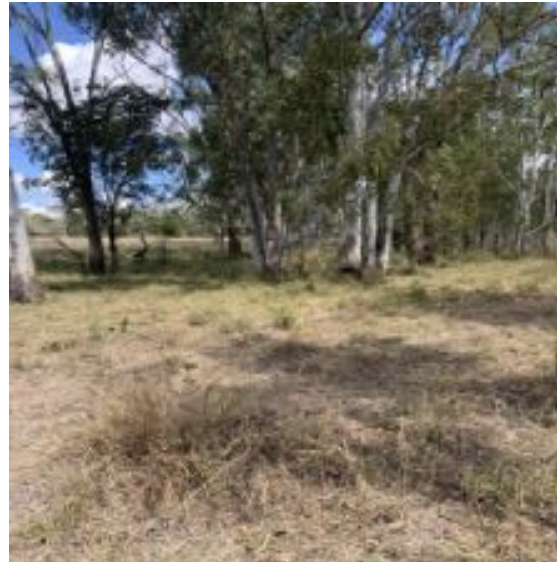
Figure 8.11 Determination 1 at Tributary 7 showing a) upstream towards dam wall, and b) downstream

Defined bed and banks:	No defined or continuous bed and banks present downstream of dam, but present upstream of dam based on desktop review.	
Extended period of flow:	Would not sustain flows for extended periods. Drainage feature likely channels localised flows and the occasional spill-over from the dam.	
Adequate flow:	Flow connectivity severely limited by an indistinct channel. Area is overgrown with terrestrial grasses and weeds.	
Habitat features:	No fish habitat present downstream but trees are characteristic of riparian vegetation. Aquatic plants present immediately upstream of road/track (<i>Eleocharis</i>).	
Is the feature a waterway providing for fish passage?	Yes – upon review of LiDAR data and DEMs, Tributary 7 is likely a waterway for fish passage.	
Low flow channel width	1 m	
Main channel width	2.8 m	
Fullbank width	5 m	
Main channel bank height	L: <1 m	R: <1 m
Fullbank bank height	L: 1 m	R: 1 m

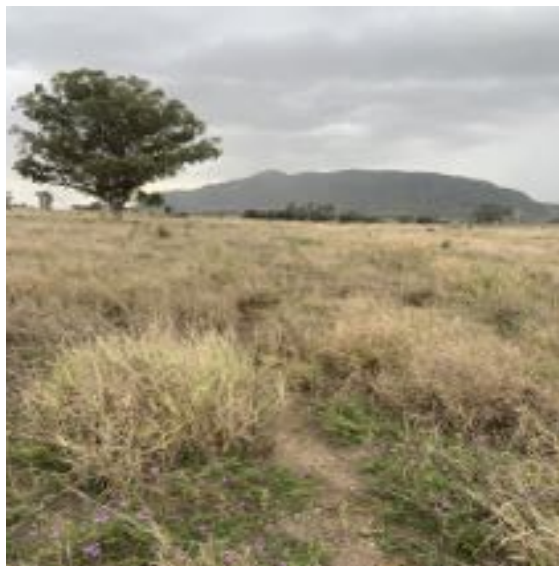
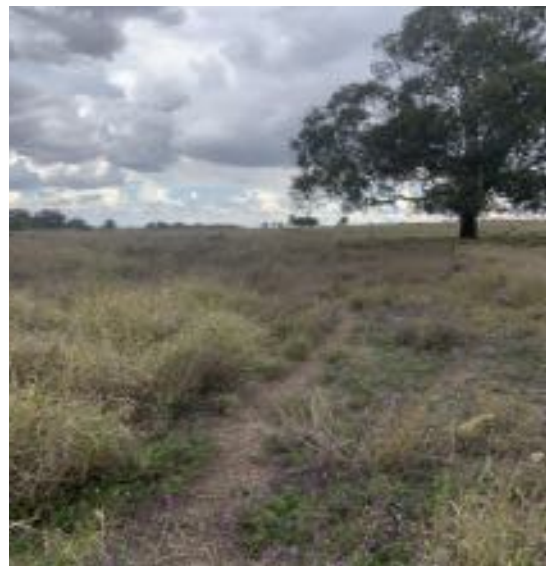
Figure 8.14 Determination 3 at Tributary 8 showing a) upstream, and b) downstream

Defined bed and banks:	No defined or continuous bed and banks present but a low flow path is evident through the paddock.	
Extended period of flow:	The presence of a yabby claw in the bed of the tributary further upstream suggests that at times, the section of Tributary 8 between T8-D1 and T8-D3 provides passage for fish and aquatic fauna from the small farm dam downstream of T8-D3.	
Adequate flow:	No features present.	
Habitat features:	Potential to provide for fish passage to dam downstream of T3.	
Is the feature a waterway providing for fish passage?	Yes	
Low flow channel width	1.5 m	
Main channel width	1 m	
Fullbank width	25 m	
Main channel bank height	L: <1 m	R: <1 m
Fullbank bank height	L: 2 m	R: 2 m

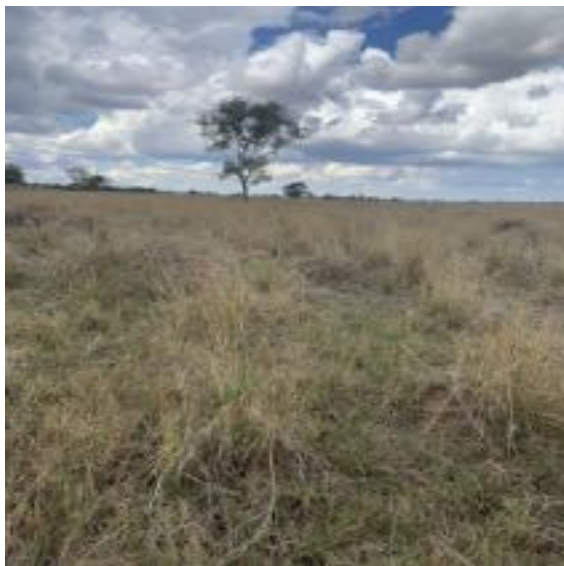
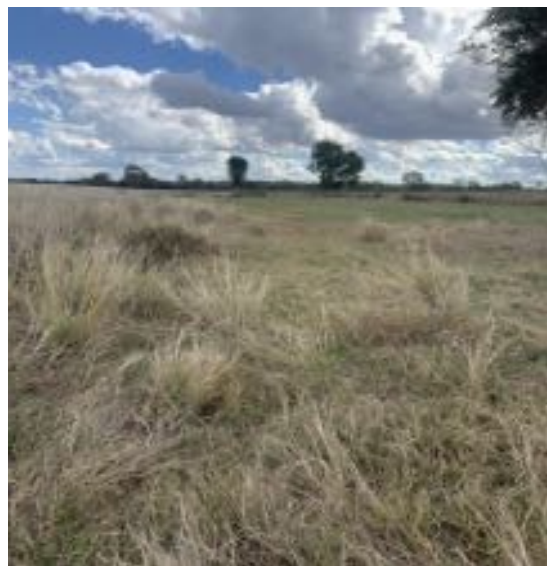
Figure 8.15 Determination 4 at Tributary 8 showing a) upstream, and b) downstream

Defined bed and banks:	No defined or continuous bed and banks present.	
Extended period of flow:	Does not flow or hold water for an extended period of time. Likely acts as drainage lines for overland flow from the local catchment.	
Adequate flow:	Feature overgrown by terrestrial weeds and grasses, indicating that flow, if any, is highly intermittent.	
Habitat features:	No waterway habitat features present despite a small depression in the landscape. Does not provide for fish habitat.	
Is the feature a waterway providing for fish passage?	No. Review of aerial photography indicates that connectivity to upstream habitat is likely to occur during flood periods,	
Low flow channel width	N/A	
Main channel width	N/A	
Fullbank width	N/A	
Main channel bank height	L: N/A	R: N/A
Fullbank bank height	L: N/A	R: N/A

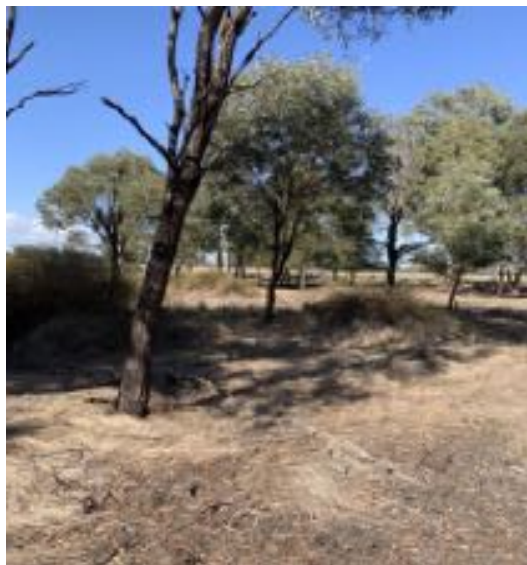
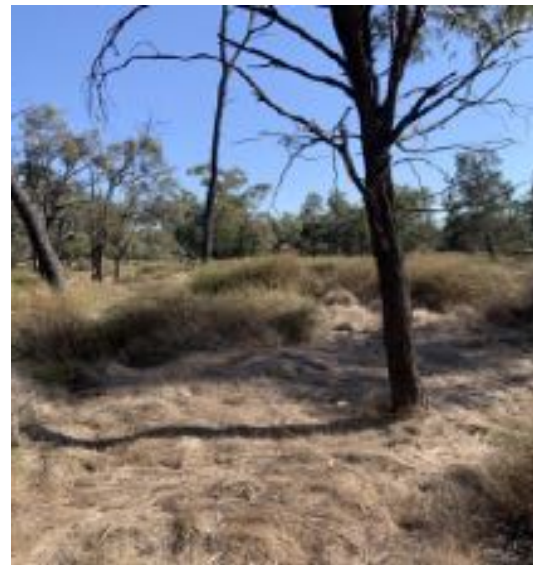
Figure 8.16 Determination 5 at Tributary 8 showing a) upstream, and b) downstream

Defined bed and banks:	No defined or continuous bed and banks present.	
Extended period of flow:	Does not flow or hold water for an extended period of time. Likely acts as drainage lines for overland flow from the local catchment.	
Adequate flow:	Feature overgrown by terrestrial grasses, trees and weeds indicating that flow, if any, is highly intermittent.	
Habitat features:	No waterway habitat features present despite a small depression in the landscape. Does not provide for fish habitat. Heavy disturbance from cattle present.	
Is the feature a waterway providing for fish passage?	No	
Low flow channel width	N/A	
Main channel width	N/A	
Fullbank width	N/A	
Main channel bank height	L: N/A	R: N/A
Fullbank bank height	L: N/A	R: N/A

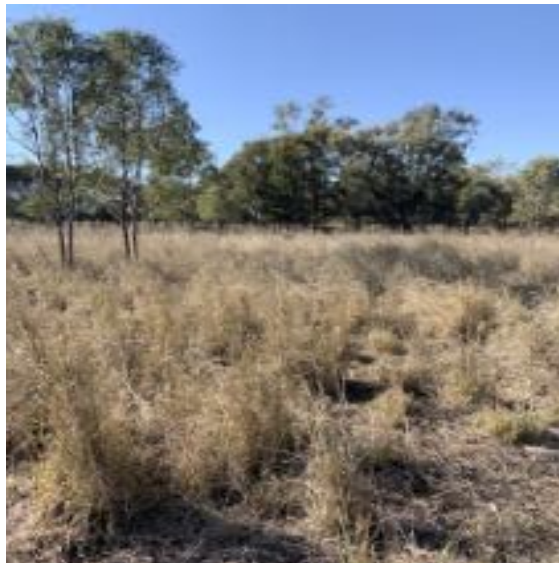
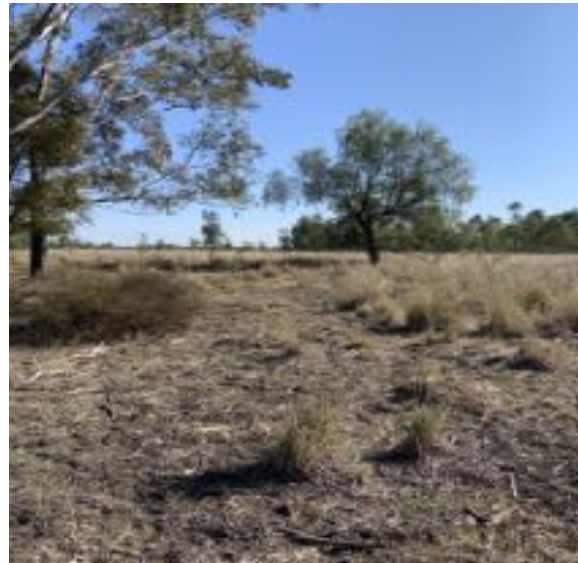
Figure 8.17 Determination 6 at Tributary 8 showing a) upstream, and b) downstream

Defined bed and banks:	Bed and banks completely absent.	
Extended period of flow:	Does not flow for an extended period. No water present, and when present water pools and settles for short periods downstream at the baseline aquatic ecology site UW1T. Likely acts as drainage lines for overland flow from the local catchment.	
Adequate flow:	Feature overgrown by terrestrial grasses, trees and weeds indicating that flow, if any, is highly intermittent.	
Habitat features:	No aquatic plants or fish habitat features present. Does not provide for fish habitat. However, snags are present downstream at site UW1T.	
Is the feature a waterway providing for fish passage?	No	
Low flow channel width	N/A	
Main channel width	N/A	
Fullbank width	N/A	
Main channel bank height	L: N/A	R: N/A
Fullbank bank height	L: N/A	R: N/A

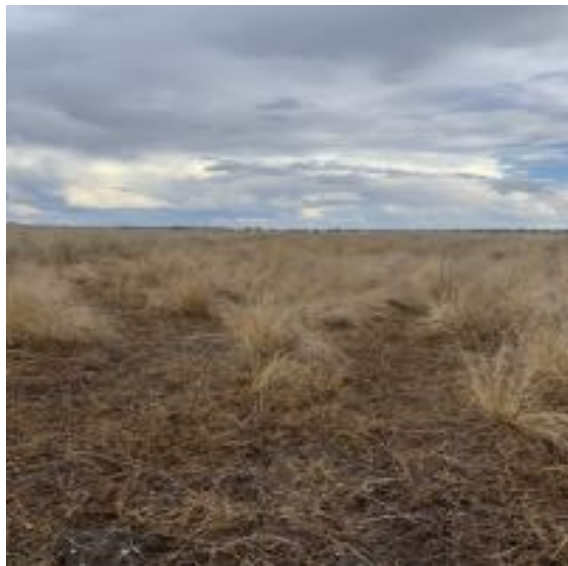
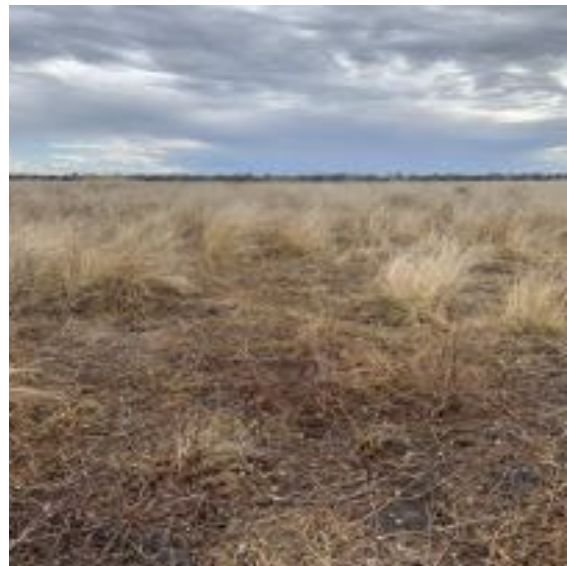
Figure 8.18 Determination 7 at Tributary 8 showing a) upstream, and b) downstream

Defined bed and banks:	No defined or continuous bed and banks present.	
Extended period of flow:	Does not flow for an extended period. A wide feature which likely channels shallow, localised flows after heavy rain.	
Adequate flow:	Feature overgrown by terrestrial grasses and weeds indicating that flow, if any, is highly intermittent.	
Habitat features:	No aquatic plant or fish habitat features present. Located upstream of the dam.	
Is the feature a waterway providing for fish passage?	No	
Low flow channel width	N/A	
Main channel width	N/A	
Fullbank width	N/A	
Main channel bank height	L: N/A	R: N/A
Fullbank bank height	L: N/A	R: N/A

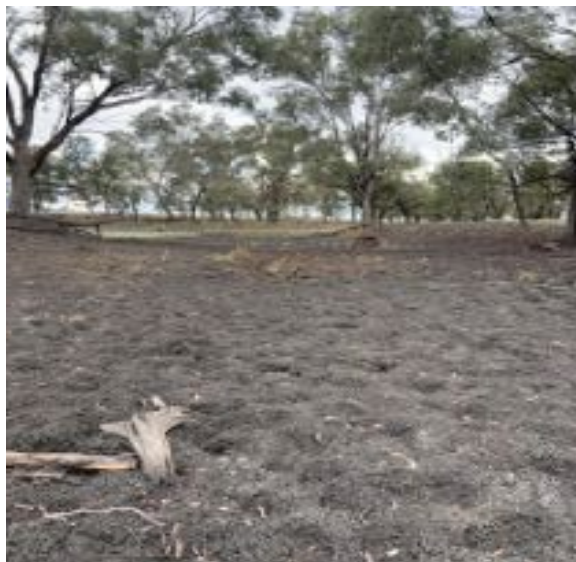
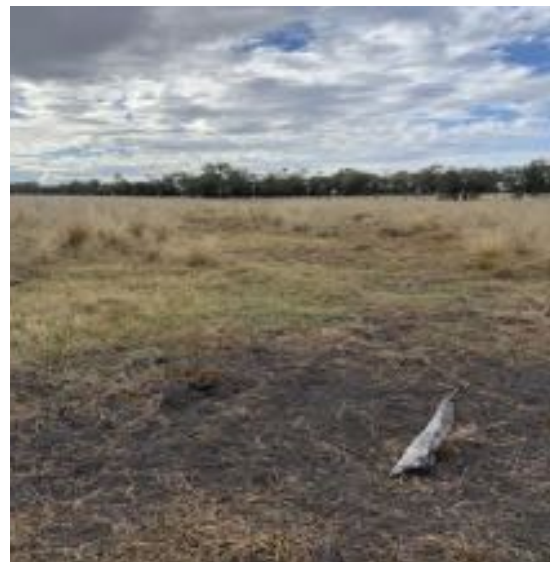
Figure 8.19 Determination 8 at Tributary 8 showing a) upstream, and b) downstream

Defined bed and banks:	Discontinuous bed and banks present.	
Extended period of flow:	Does not flow for an extended period. Likely acts as drainage lines for overland flow from the local catchment.	
Adequate flow:	Feature overgrown by terrestrial grasses, trees and weeds indicating that flow, if any, is highly intermittent.	
Habitat features:	Minimal fish habitat features and substrate diversity. Aquatic plants present and centred around the Dam, which is located immediately upstream.	
Is the feature a waterway providing for fish passage?	No	
Low flow channel width	1.5m	
Main channel width	5m	
Fullbank width	25m	
Main channel bank height	L: <1m	R: <1m
Fullbank height	L: 1.5m	R: 1.5m
