DRAFT PROGRESSIVE REHABILITATION AND CLOSURE PLAN

BARALABA SOUTH PROJECT

PREPARED FOR
BARALABA SOUTH PTY LTD

19 DECEMBER 2023

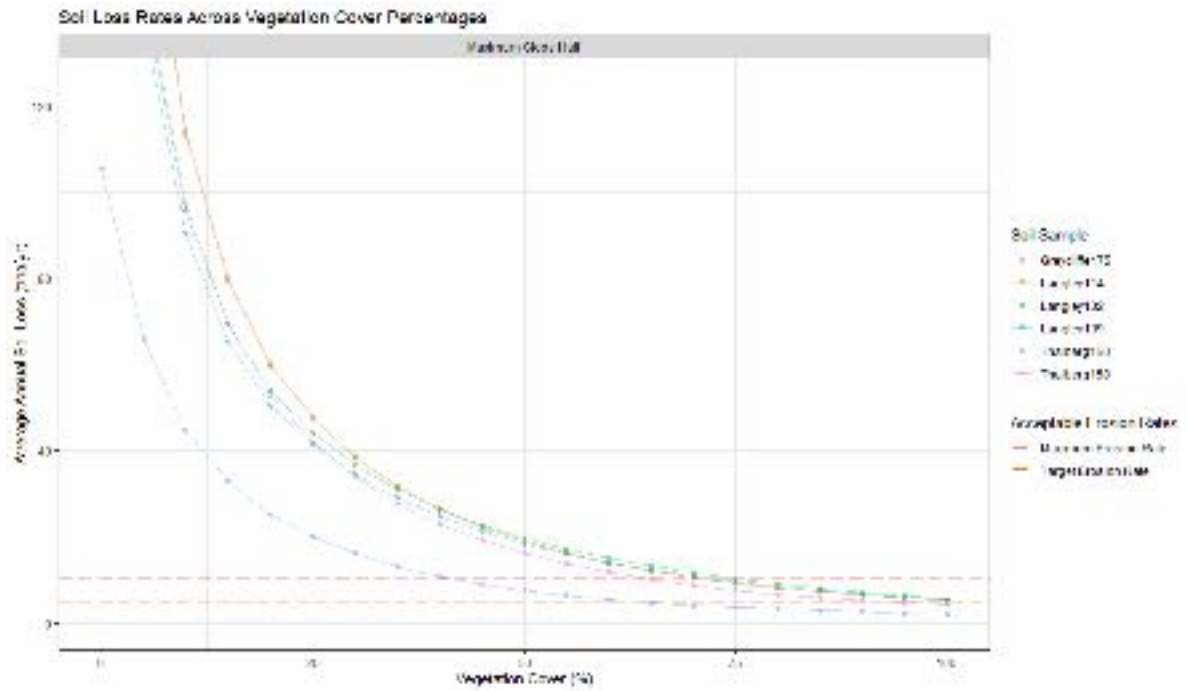
Figure 33: Average annual soil loss rates (t/ha/year) with vegetation cover, 234 m slope

882 100-year WEPP iterations were run, covering the range of soil samples and land use management profiles identified above. To determine the worst case, maximum potential erosivity of the slope, the average annual soil loss, expressed in tonnes per hectare per year, for each iteration was calculated and assessed against a target and maximum erosion rate. For mining rehabilitation, a maximum tolerable erosion rate of 10 t/ha/yr is generally considered acceptable (Lu 2001) and was adopted for this analysis. The results of the analysis are shown in Figure 32, Figure 33 and Figure 34.

- 75% vegetation cover is required for a slope length of 234 m (50% of the maximum slope length) (Figure 33); and
- 60% vegetation cover for slopes of 117 m (25% of the maximum slope length) (Figure 34).

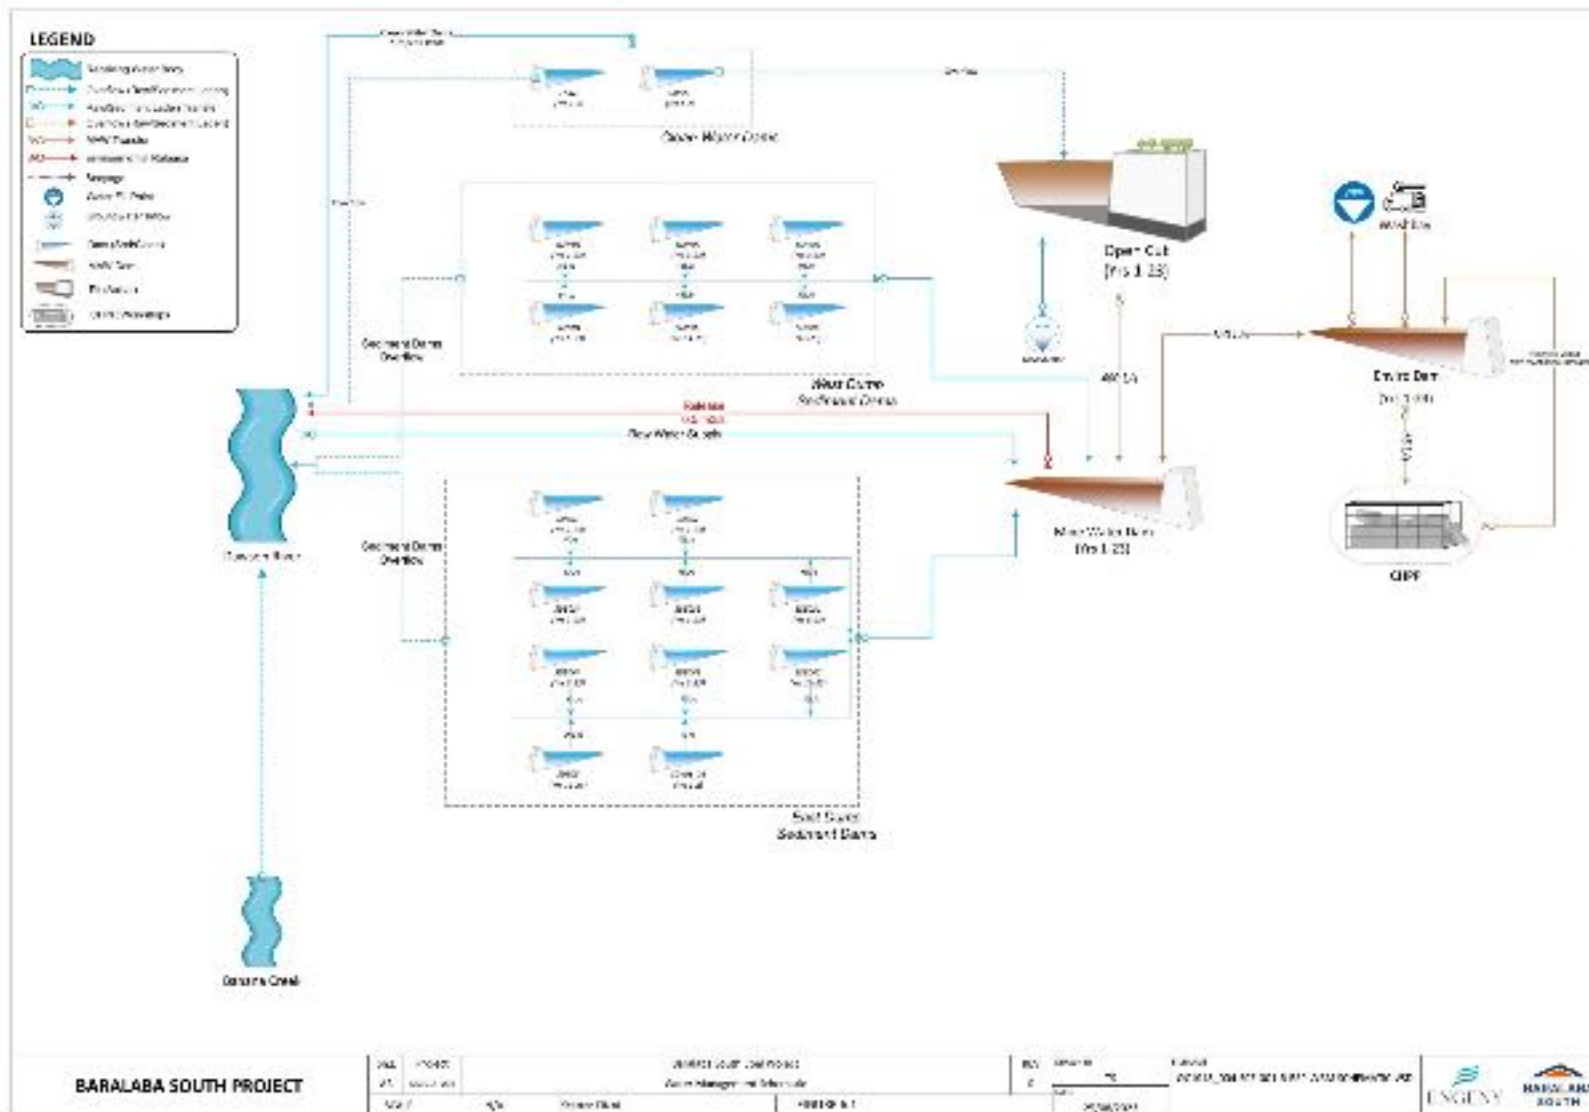
Figure 36: Operational mine water management schematic

A schematic of the operational water management system is provided in Figure 36.

Sediment dams are proposed as the primary mechanism to manage runoff from overburden and disturbed areas, which may have elevated concentrations of suspended solids. Water stored in the sediment dams is expected to contain elevated concentrations of suspended solids only following rainfall events. Seepage from these structures is not expected to contain dissolved concentrations of contaminants that could have a significant impact to the receiving groundwater or surface water environment (Appendix E, Engeny 2023a). Overflows from the sediment dams are not expected to contain concentrations of contaminants that could have a significant impact to the receiving environment.

Diversion of clean catchment to clean water storages will reduce the harvest of clean runoff in the mine water management system. Two clean catchment diversions located on the eastern side of the MLA are proposed and will direct runoff from a sub-catchment of Mount Ramsay around the Project. A third clean water channel is proposed to divert water in Tributary 8 around the proposed out-of-pit dump to ensure the drainage path is unaffected by the Project.

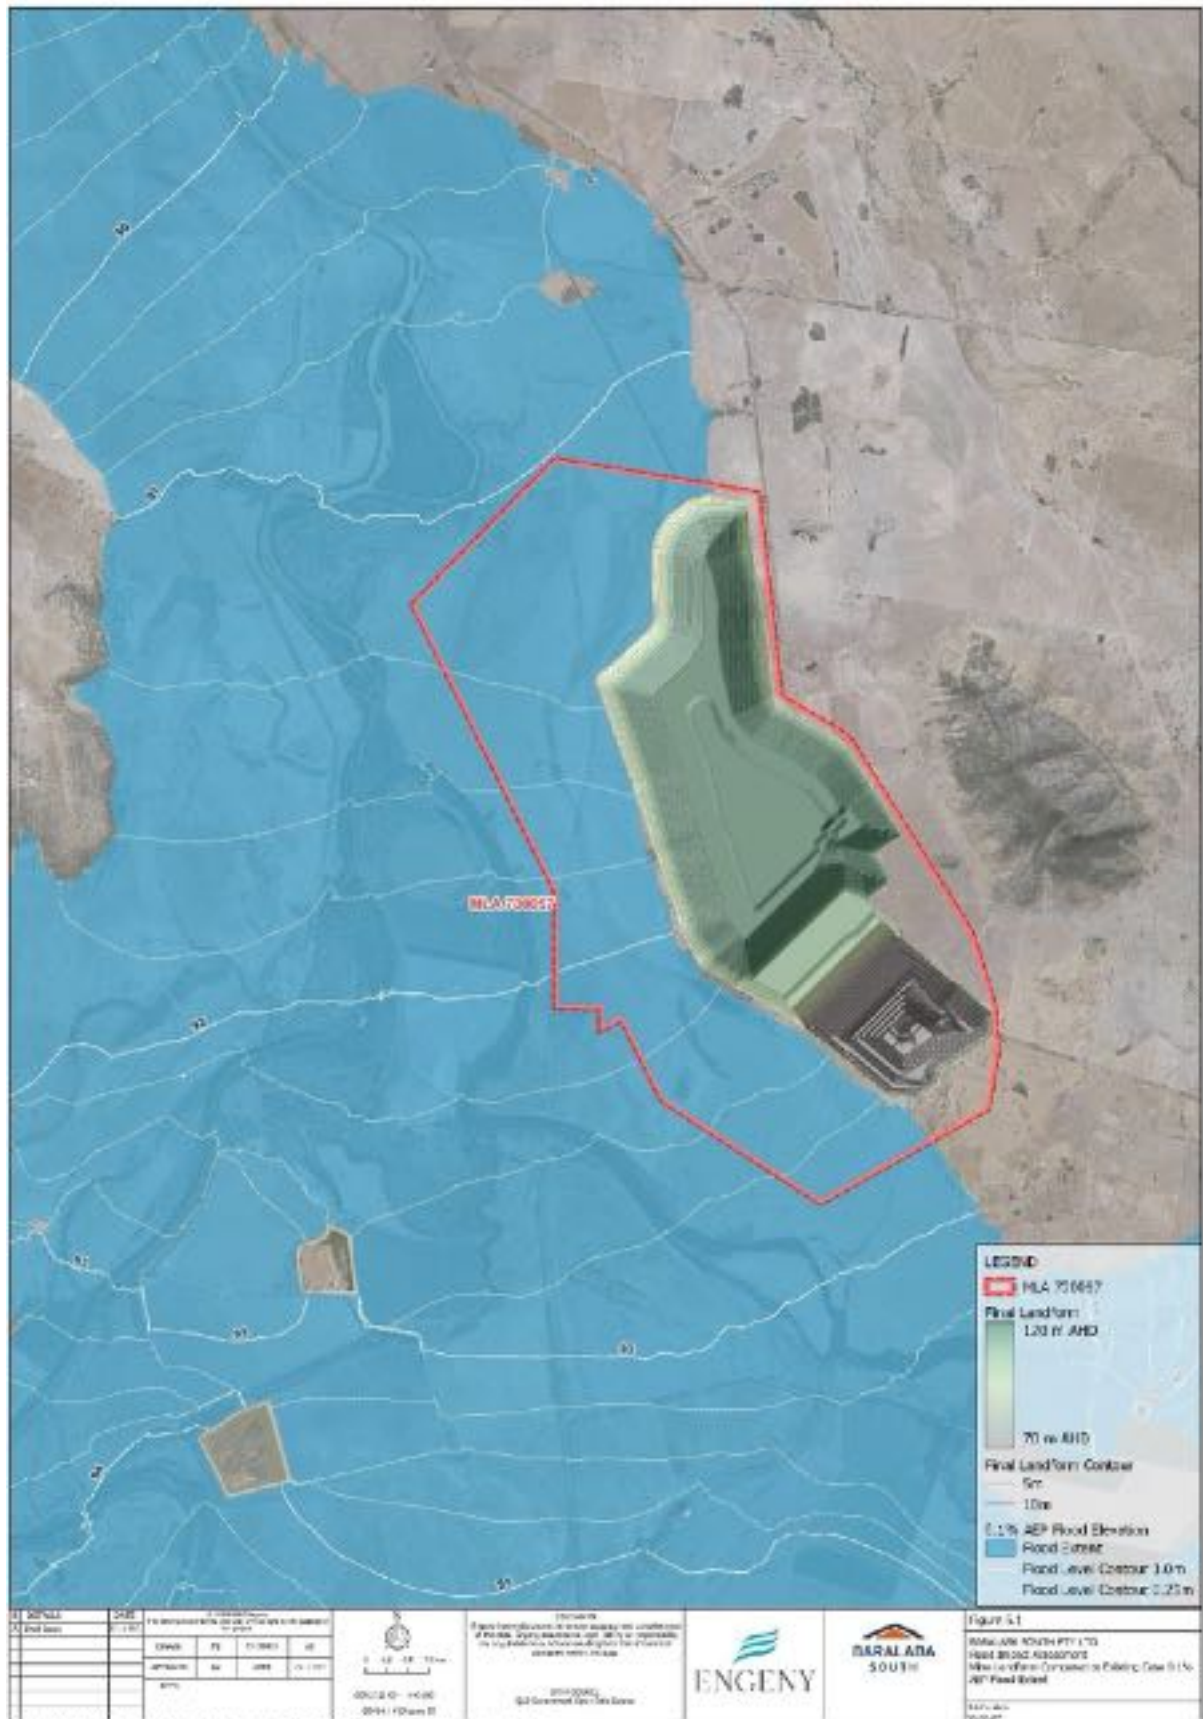
Figure 38: 0.1% AEP flood extent and the mine developed case

The final landform is predominately located outside the 0.1% AEP flood extent (Figure 38).

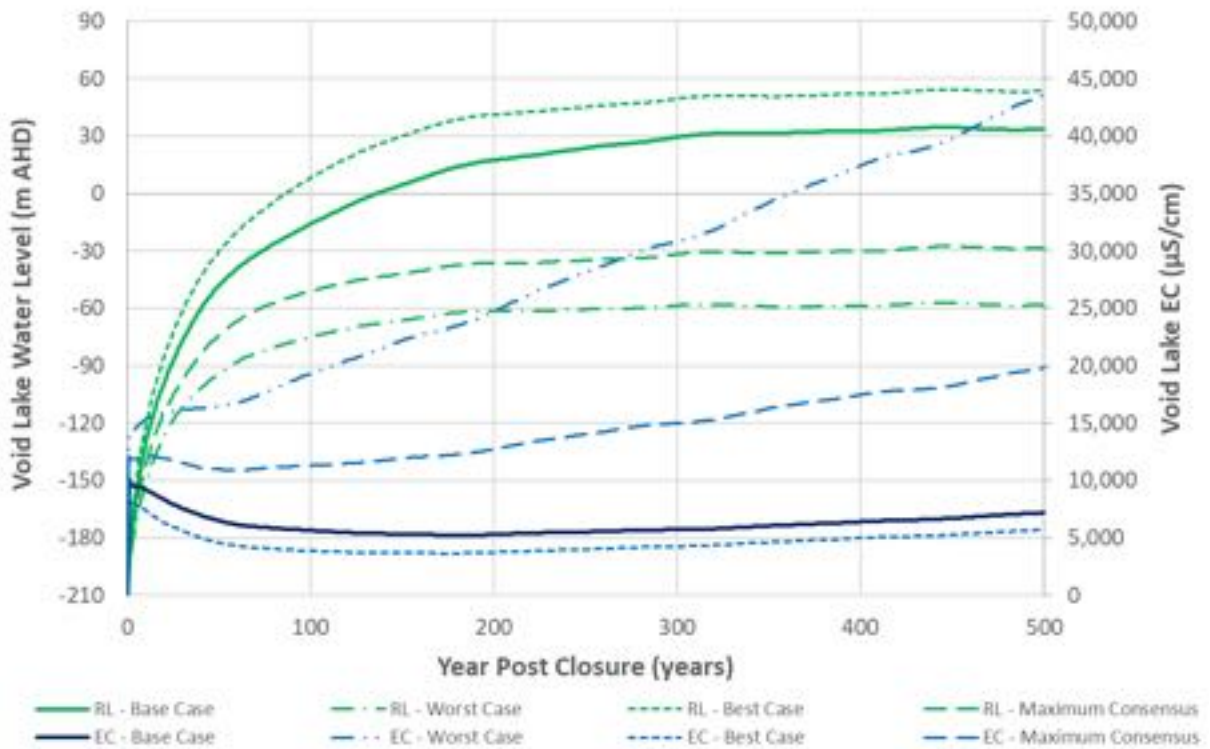
Figure 43: Final void water level – water mitigation scenario: climate change sensitivity analysis

- Under all climate change scenarios using the 2090 projections, salinity within the void is predicted to increase due to increased evaporation rates (Figure 43).
